CONDITIONS ASSESSMENT

ANTIOCH BAPTIST CHURCH

CRAWFORDVILLE, GA

LANDMARK PRESERVATION LLC
SPRING 2020

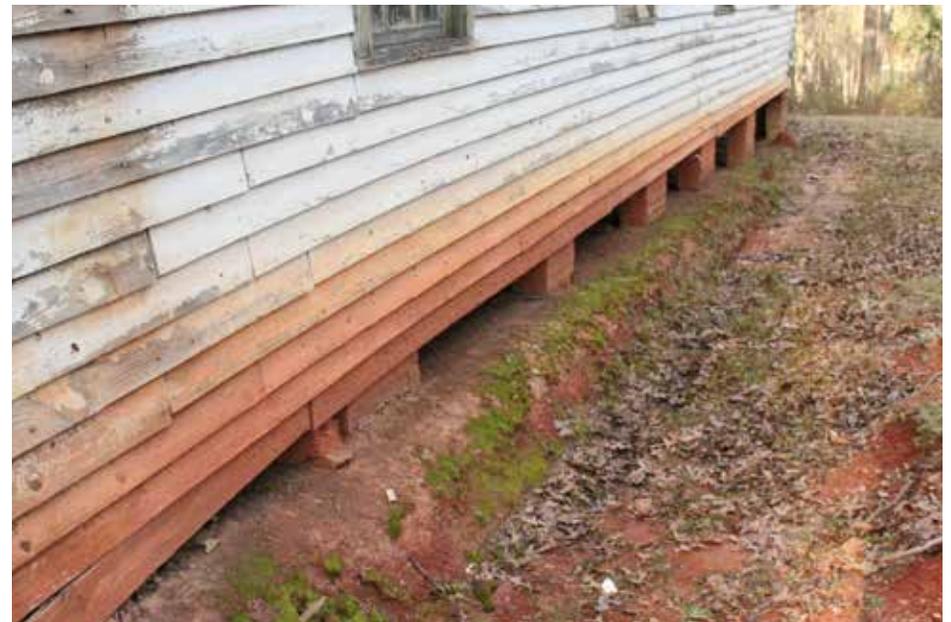
Figure 15.

- Organic growth
- Deteriorated mortar
- Spalling brick
- Missing bricks (northwest corner)
- One brick pier replaced with concrete
- Sinking piers
- Grade buildup

- Biological growth should be gently removed by hand, and piers should be treated with a biological cleaner and growth inhibitor (D/2 Biological Solution or equivalent).
- Existing deteriorated mortar (lime based) should be gently removed and bricks should be repointed. New mortar should match historic mortar in color, texture, joint profile, and composite strength.
- Spalled bricks should be carefully removed in a manner that does not cause damage to adjacent bricks.

- Replacement bricks should be laid by a qualified mason. Any new bricks to match existing in dimension, color, and texture as accurately as possible.
- Rebuild three piers (two brick, one stone - northwest corner) to level.
- Jack building to alleviate deflection and repair framing in kind (see spalling section).
- Excavate grade to original level on southeast elevation.

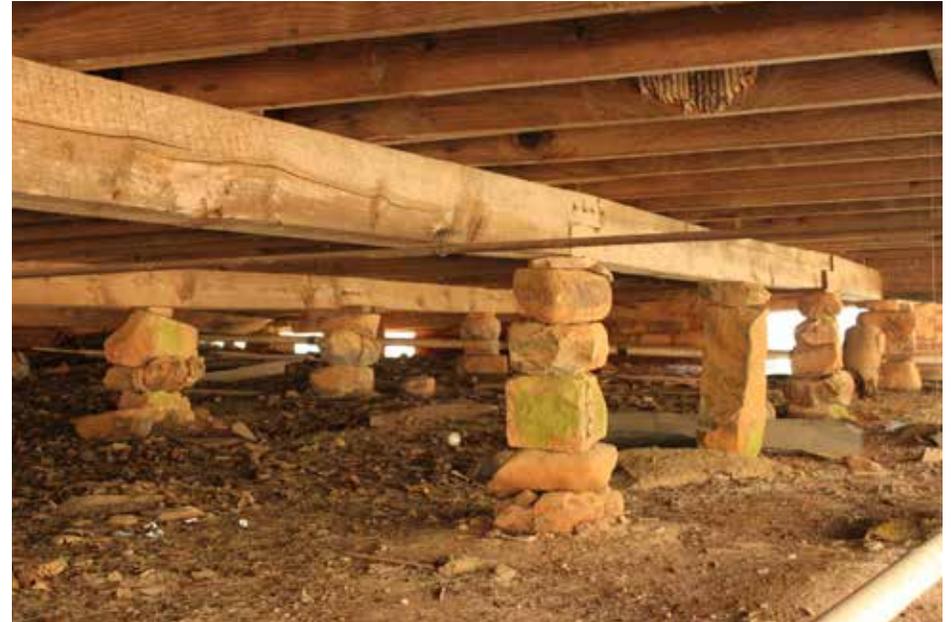
Figure 19.

- One of the piers is a combination of wood and stone.
- One additional pier has been replaced with a wood block.

- Confirm stability of existing piers
- Replace wooden pier elements with appropriate stone

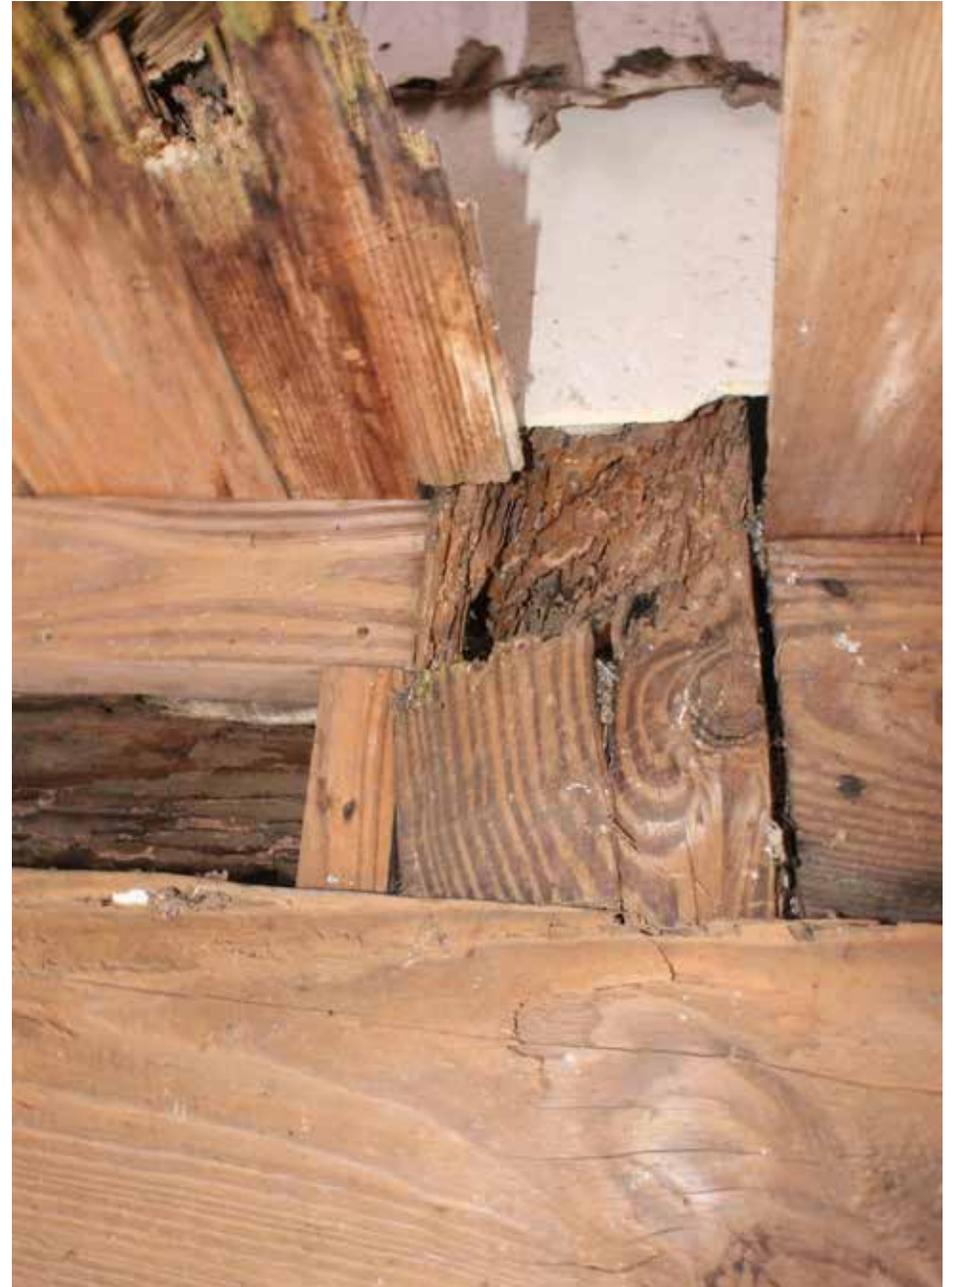
Figure 23.

- Termite mound
- Termite damage

- Treat the ground and building for termites and other wood destroying organisms.
- Closely inspect for termite damage in framing.

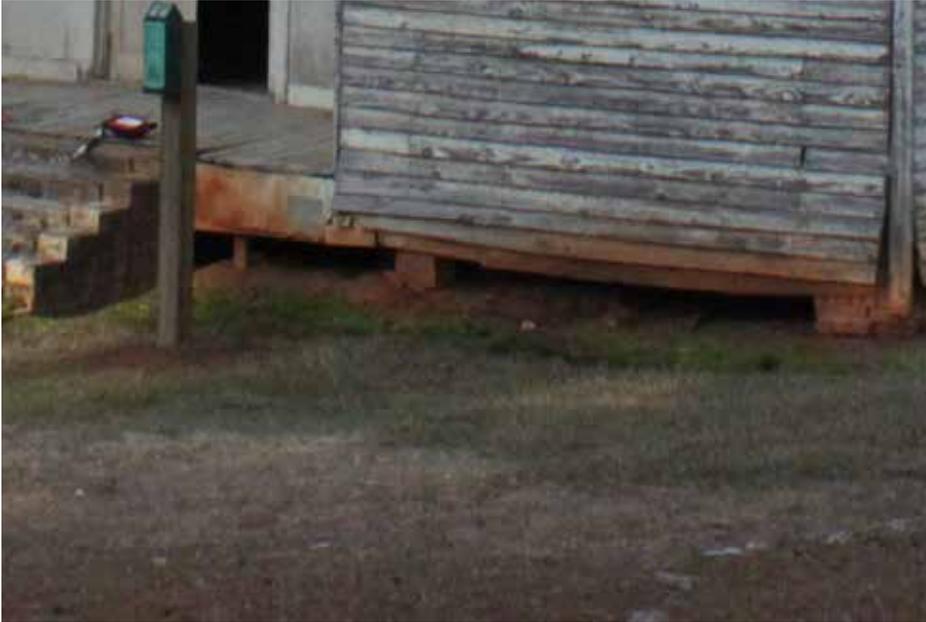
Figure 24. A termite mound is found under the southwest facade of the building

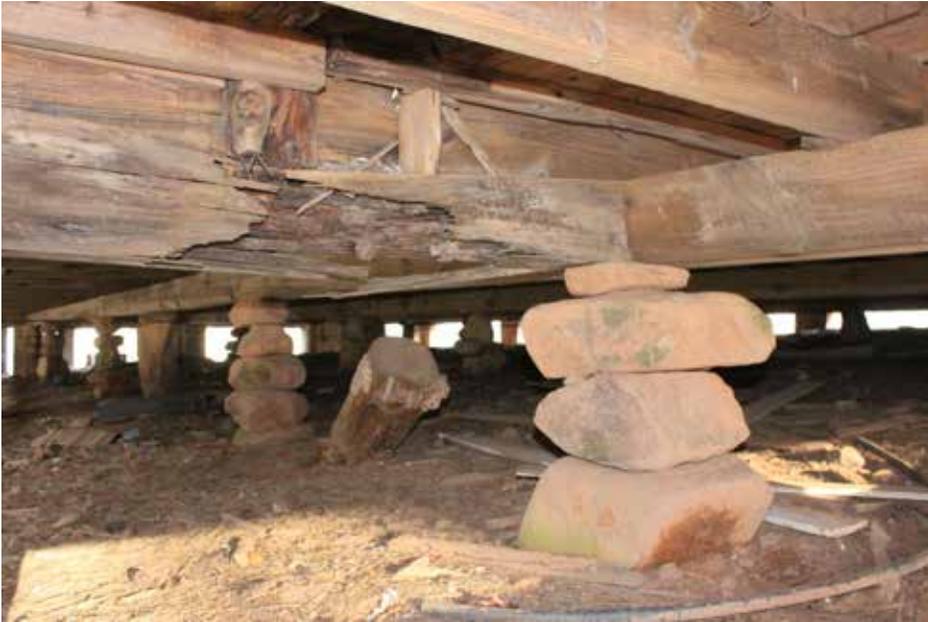
Figure 26.

- Deteriorated timbers visible from crawl space.
- Sagging porch deck
- Structurally inappropriate joinery in summer beam.
- Water entry has deteriorated some of the rafters and tower framing elements over the restrooms.

- The bottom of all wall framing is currently concealed by the siding, and a full inspection is not possible. Remove bottom two courses of siding from the building in order to fully expose piers, sills, and bottom of wall framing. Upon removal of siding, the precise condition of the studs can be determined.

- Sister inappropriate joinery in summer beam with steel plates and through-bolts.
- Determine the causes of water

intrusion in the attic and address accordingly. Once the causes of water intrusion have been resolved, the deteriorated, water-damaged rafters and framing elements should be carefully repaired by a qualified, experienced carpenter. Members with minor to moderate deterioration will be sistered where possible utilizing material of in-kind dimension and species. Severely deteriorated members will be replaced utilizing material of in-kind dimension and species where absolutely required.

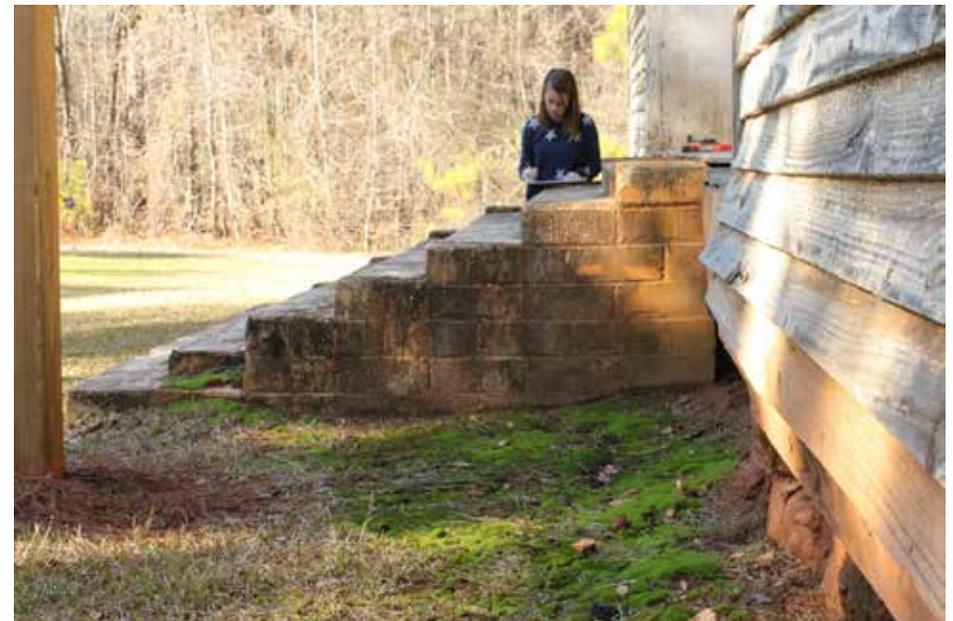
Figure 30.

- Cracks in blocks
- Edge blocks pulling away
- Biological growth

- Broken concrete
- Missing blocks
- Edge blocks pulling away from central stairs
- Deteriorated mortar
- Loose banister (only one)
- Biological growth

- Front: Repair stairs in-kind. Clean biological growth using the gentlest means possible.
- Rear: Repair stairs in-kind. Clean biological growth using the gentlest means possible. Replace existing handrail with a sympathetic substitute.

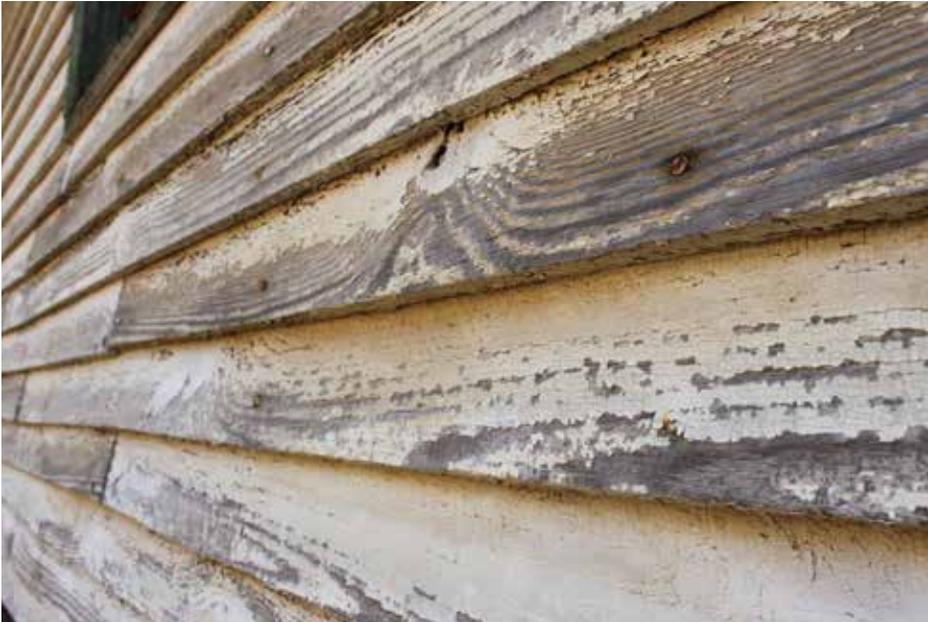
Figure 34.

- Loose clapboards
- Rotten / Damaged clapboards
- Missing clapboards
- Oxidized fasteners
- Biological growth (rear)
- Dirt build up
- Ghost line of previous roof (rear)
- Failed paint

- Re-attach all loose siding with appropriate stainless fasteners.
- Replace rotten, damaged, or missing siding with wooden clapboards that match in size and species, taking care to stagger vertical joints.
- Remove oxidized fasteners and replace with appropriate material or remove oxidation from fasteners with a wire brush and treat with rust inhibitor (Ospho or equivalent). Fasteners

should then be primed and painted.

- Carefully remove any vegetation by hand, and clean remnants of biological growth with appropriate solution
- Remove oxidation from metal flashing at ghost line over apse with a wire brush and treat with a rust inhibitor (Ospho or equivalent). The flashing should then be primed and painted.
- Scrape loose and failing paint using hand tools. Great care should be taken to avoid gouging the wood. Sand the siding to remove rough surfaces and previous careless tool marks. Appropriate primer and paint should then be applied with brushes.

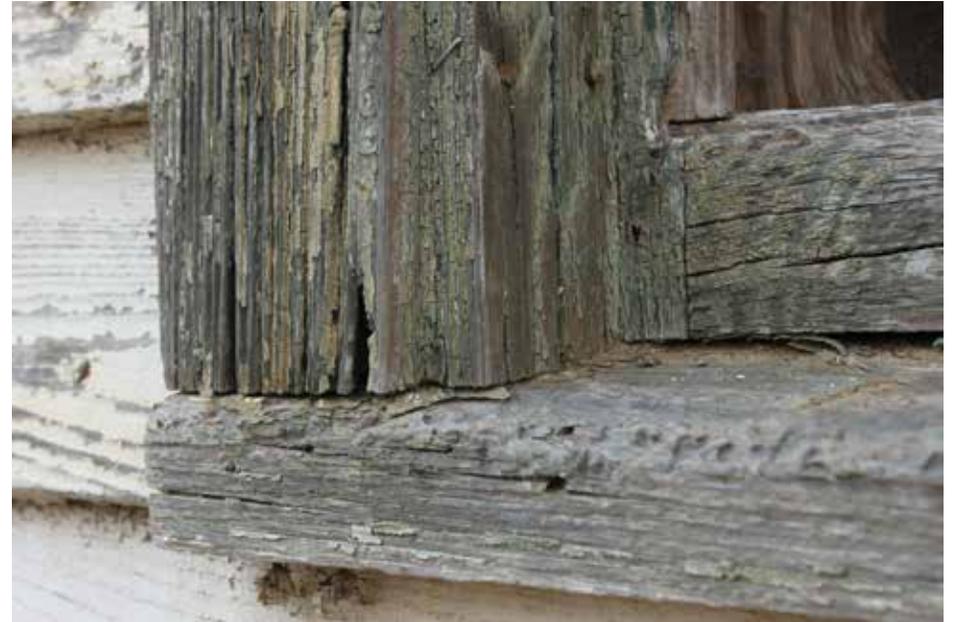
Figure 37.

- Failing rake board
- Deteriorated soffit
- Rotten / damaged window trim and sills
- Failing Paint

- Re-attach all loose trim in good repair with appropriate stainless fasteners.
- Replace rotten, damaged, or missing trim with elements that match in size, species, and dimension.
- Remove oxidized fasteners and replace with appropriate, corrosion resistant fasteners; or wire brush fasteners and treat with rust inhibitor (Ospho or equivalent). Fasteners should then be primed and painted.
- Scrape loose and failing paint using hand tools. Great care should be taken to avoid gouging the wood. Sand the siding to remove rough surfaces and previous careless tool marks. Appropriate primer and paint should then be applied with brushes.

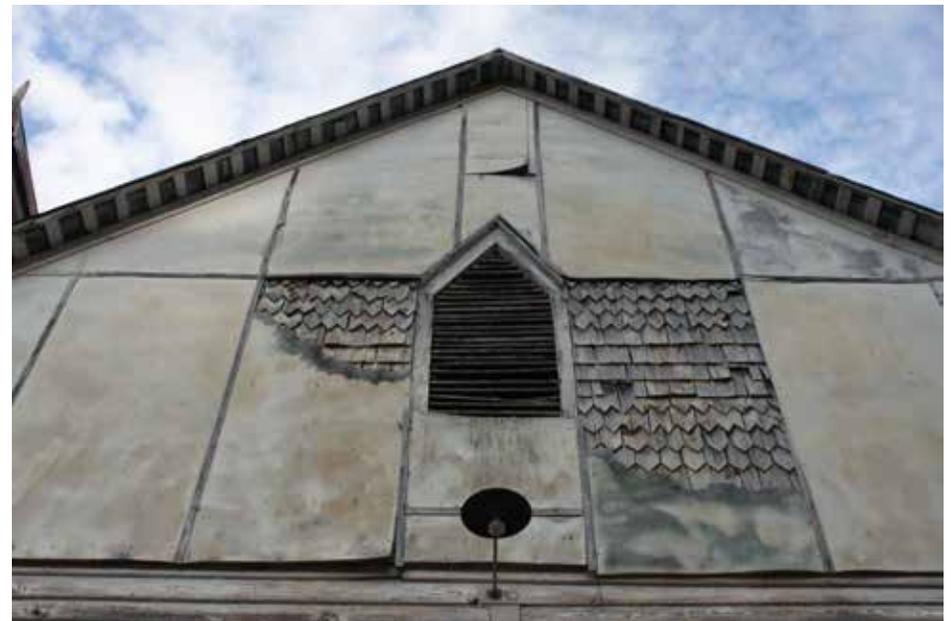
Figure 40.

- Plywood sheathing is failing and peeling away. Falling pieces of plywood over the entrance pose a threat to life safety, but they also pose a threat to the integrity of the materials they cover. Water intrusion between the plywood and the wood shingles could lead to further deterioration. Beyond life safety, the plywood is also concealing the shingles, which are a historic, character defining feature of the building.

- Remove plywood to expose wood shingles.
- This removal should be performed carefully so as not to damage the shingles underneath. Condition of the concealed shingles remains unknown, but repairs can be reasonably expected. Loose shingles in good repair should be re-attached, and deteriorated shingles should be removed. New shingles should be

fabricated, and these replacements should continue the present pattern and match the existing shingles in species, dimension, and profile.

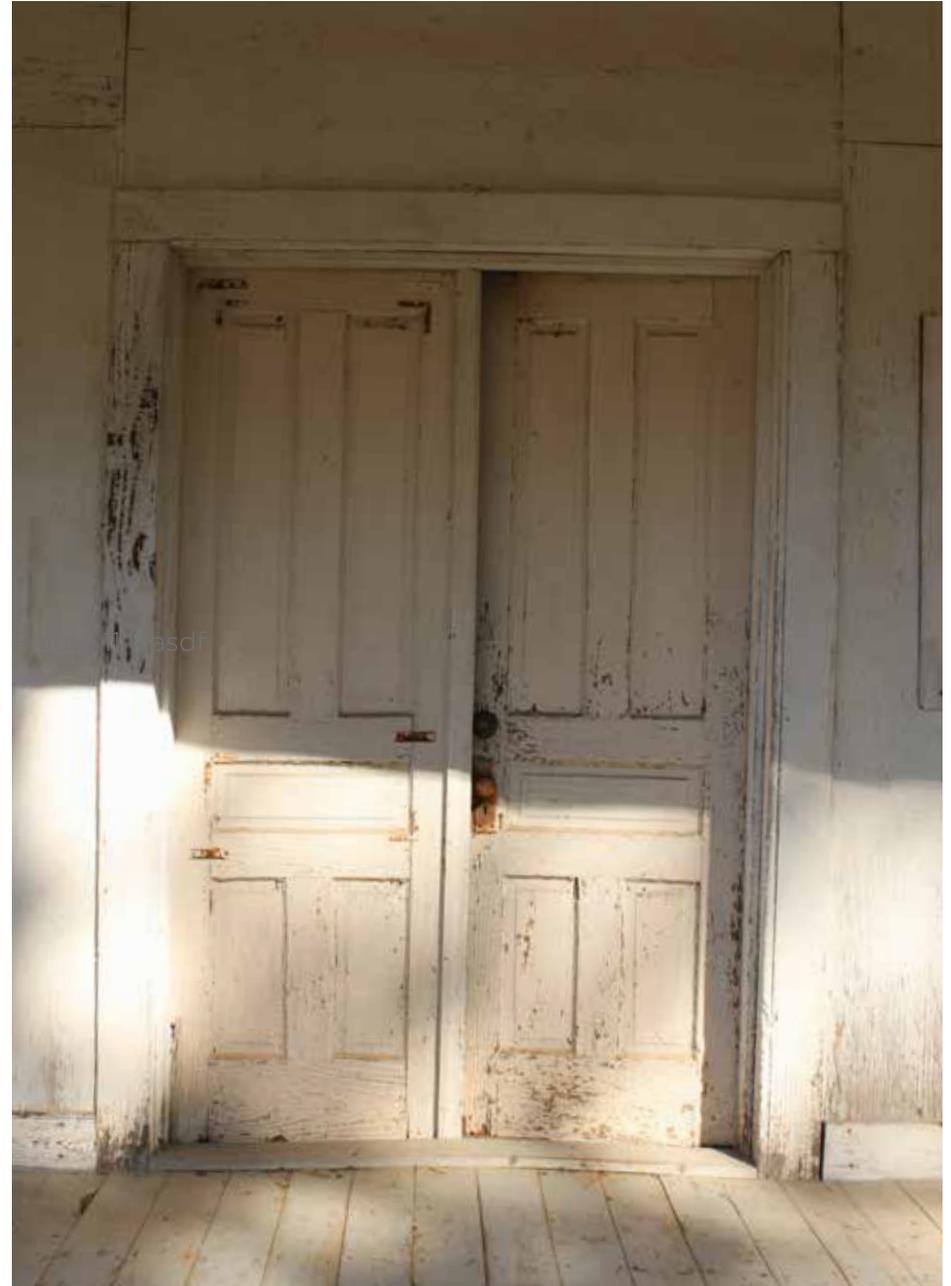
Figure 41.

- Failing, oxidized hardware
- Failure to close and lock
- Deteriorating wood
- Failing paint

- Clean and repair hardware in order to restore functionality. Securing the building envelope is of utmost priority; doors need to be able to completely close and lock.
- Treat moderately deteriorated areas of wood casing with consolidant and two part epoxy to fill voids (West System or equivalent). Severely deteriorated wood members should be removed and replaced with wood Dutchmen of in-kind species.
- Scrape off loose and failing paint using hand tools. Apply appropriate primer and paint using brushes.

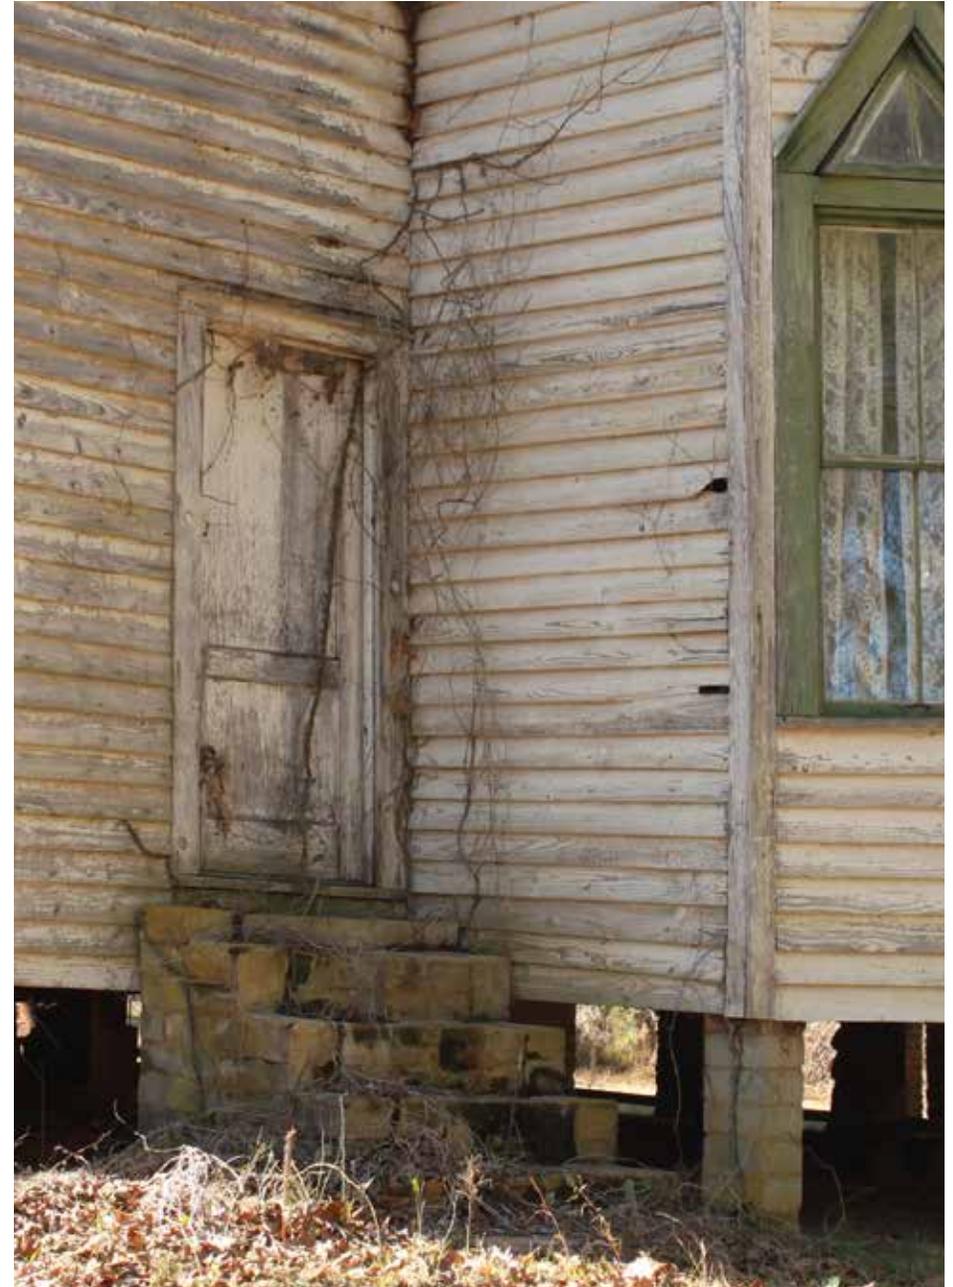
Figure 42.

- Missing hardware.
- Failure to close and lock
- Deteriorating wood.
- Failing paint

- Clean and repair hinges in order to restore functionality
- Replace missing hardware with appropriate. Securing the building envelope is of utmost priority; doors need to be able to completely close and lock.
- Treat moderately deteriorated areas of wood casing with consolidant and two part epoxy to fill voids (West System or equivalent). Severely deteriorated wood members should be removed and replaced with wood Dutchmen of in-kind species.
- Scrape off loose and failing paint using hand tools. Apply appropriate primer and paint using brushes.

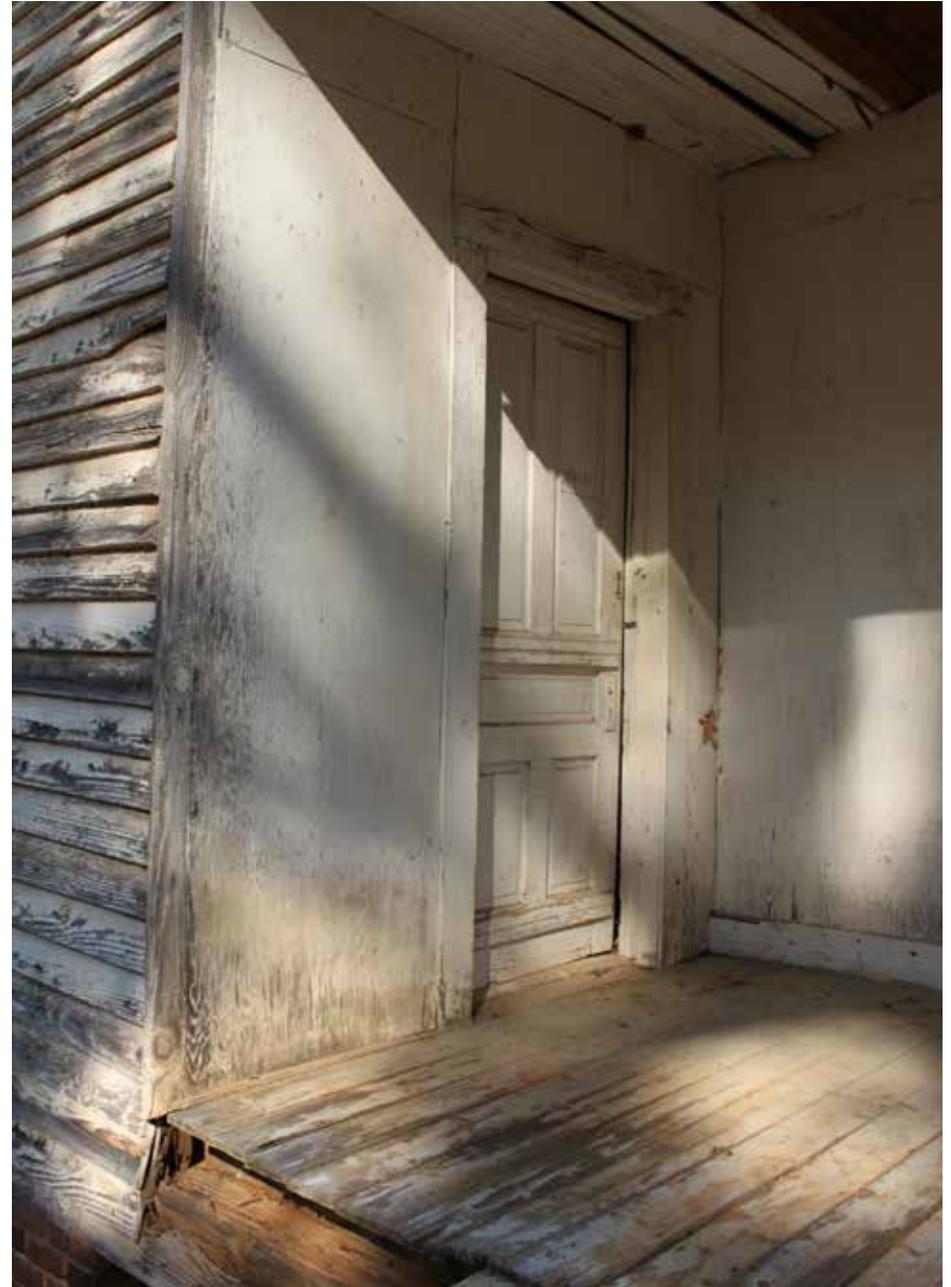
Figure 43.

- Failing, oxidized hardware
- Failure to close and lock
- Deteriorating wood
- Failing paint

- Clean and repair hardware in order to restore functionality. Securing the building envelope is of utmost priority; doors need to be able to completely close and lock.
- Treat moderately deteriorated areas of wood casing with consolidant and two part epoxy to fill voids (West System or equivalent). Severely deteriorated wood members should be removed and replaced with wood Dutchmen of in-kind species.
- Scrape off loose and failing paint using hand tools. Apply appropriate primer and paint using brushes.

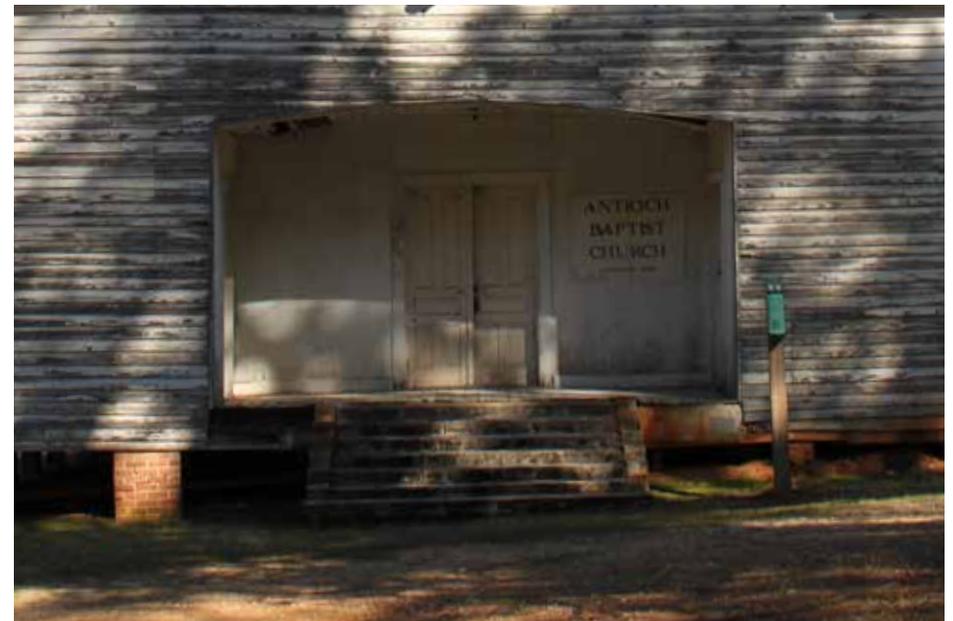
Figure 47.

- Structural deficiencies (reference the framing section)
- Deteriorated, loose deck boards
- Oxidized fasteners
- Loose beadboard
- Failing paint

- Reference the framing section for recommendations.
- Remove and replace deteriorated decking. New boards should match existing in species, dimension, and profile.
- Failing, oxidized fasteners should be removed and replaced with stainless steel fasteners
- Reattach loose beadboard. Replace failing portions with new beadboard that matches existing in species, dimension, and profile.

- Remove plywood cladding to reveal siding below. Condition of concealed siding remains unknown, but repairs can be reasonably expected. Deteriorated wood members should be repaired. Severely deteriorated members should be replaced with wood Dutchmen of an in-kind species.
- Future restoration should include hand scraping of all painted wood surfaces to remove loose and failing paint. Prepared substrate should receive a historically appropriate paint finish.

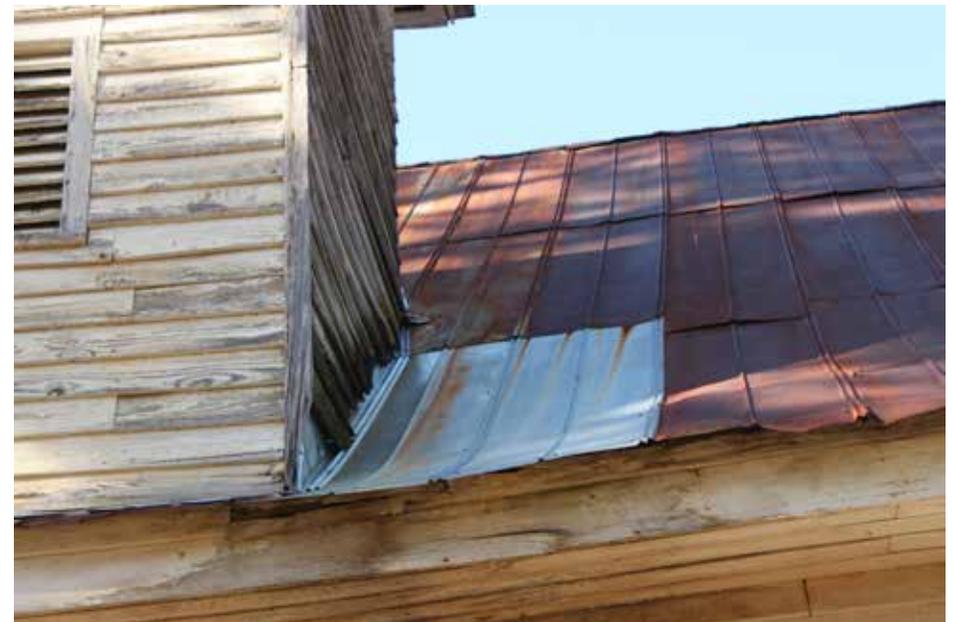
Figure 51.

- Pin holes throughout, more substantial at ridge
- Oxidized metal sheets
- Deficient flashing and ridge caps

- Replace failing and significantly oxidized sheets with in-kind material.
- Recoat entire roof with Henry's Rubberized Aluminum Roof Coating (or equivalent material).
- Replace flashing.

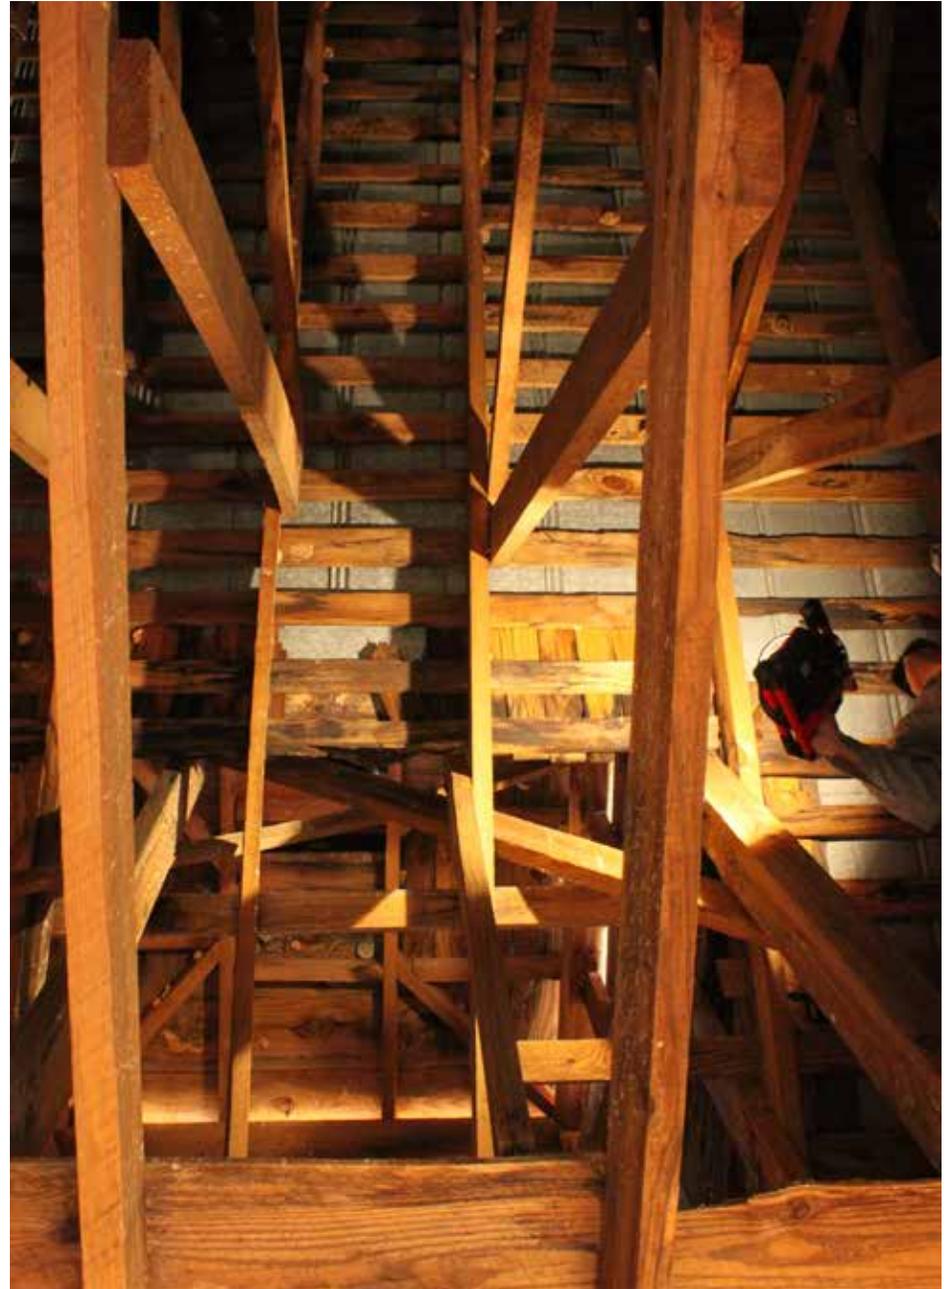
Figure 53. Underneath of metal roof as seen in the attic space

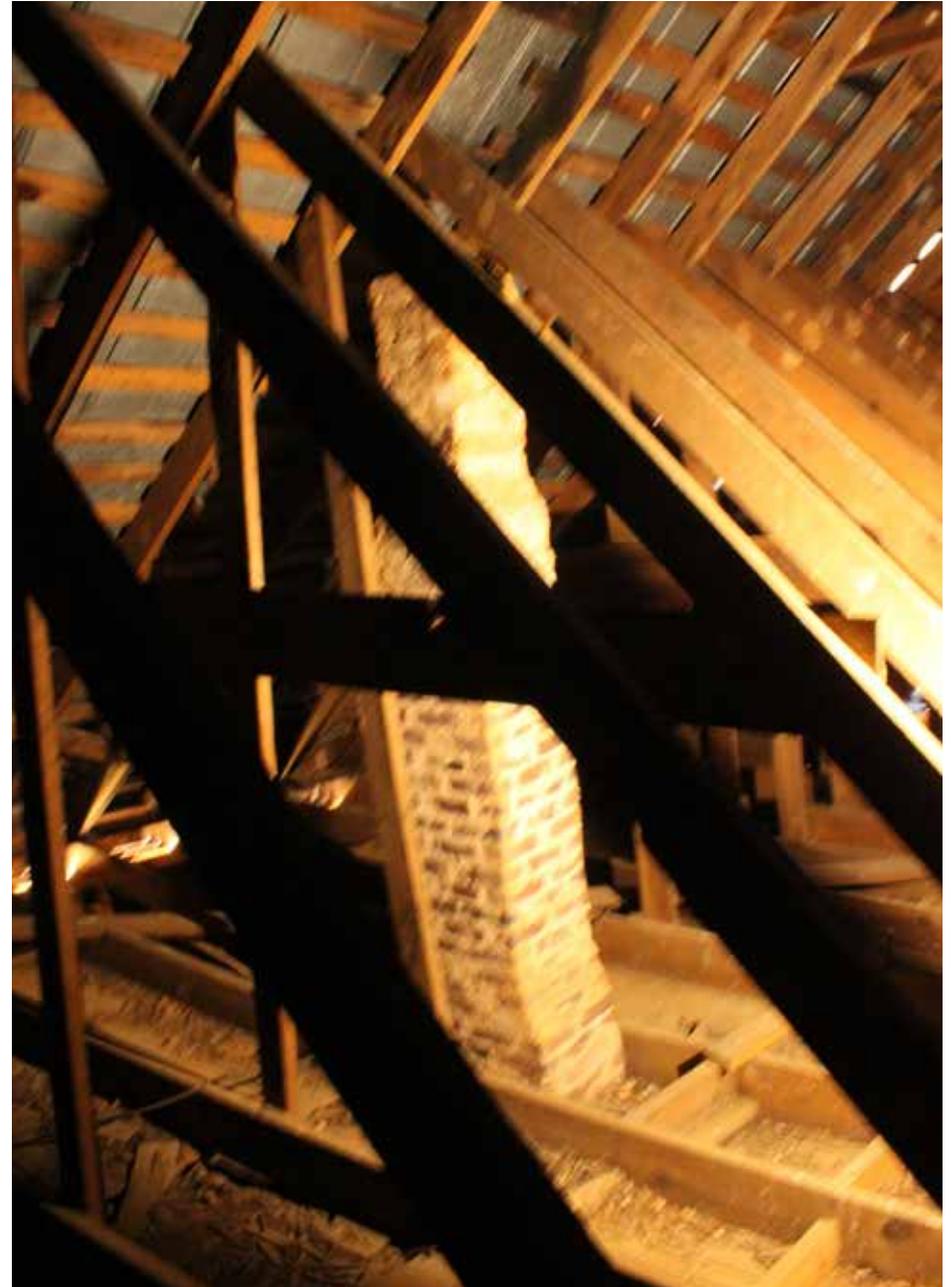
Figure 54.

- Leaning masonry chimney suspended over sanctuary ceiling is at risk of complete failure and presents an immediate threat to life safety.
- Damaged bird wire on attic louvers has allowed birds access to the attic and resulted in a blanketing of droppings.

- **Remove masonry chimney as a life safety precaution. The heavy mass is leaning perilously and potential for imminent collapse presents a very real threat to the safety of anyone entering the structure.**
- Replace bird wire on attic vent louvers.

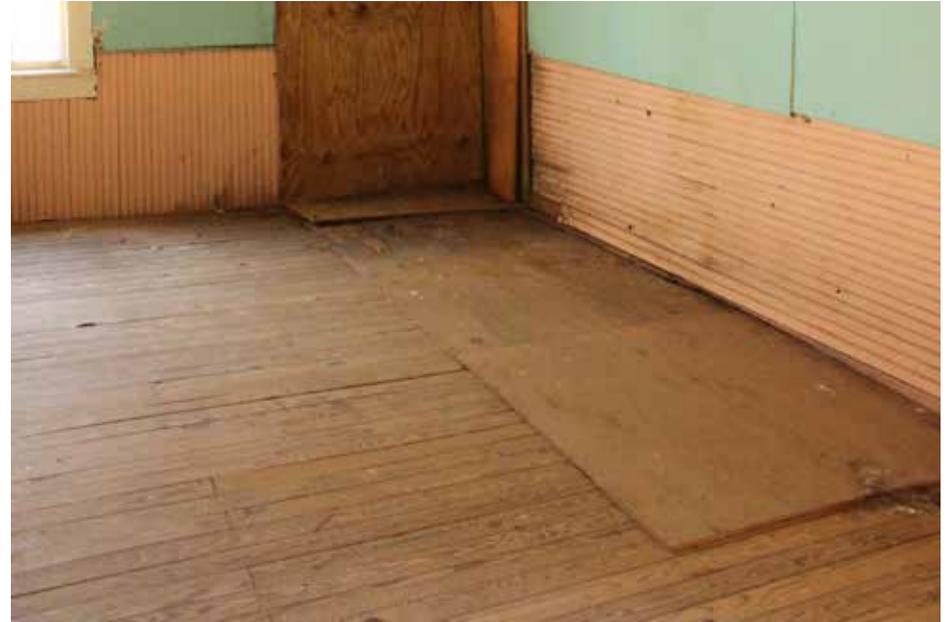
Figure 57.

- Deteriorated flooring covered by plywood in the southern and eastern corners.
- Scattered holes
- Gouges under column supporting chimney.

- Remove all deteriorated flooring and replace with flooring to match existing in species, dimension, and joints.
- Holes to be filled and gouges to be repaired by qualified carpenter once the chimney and its requisite supporting column have been removed.

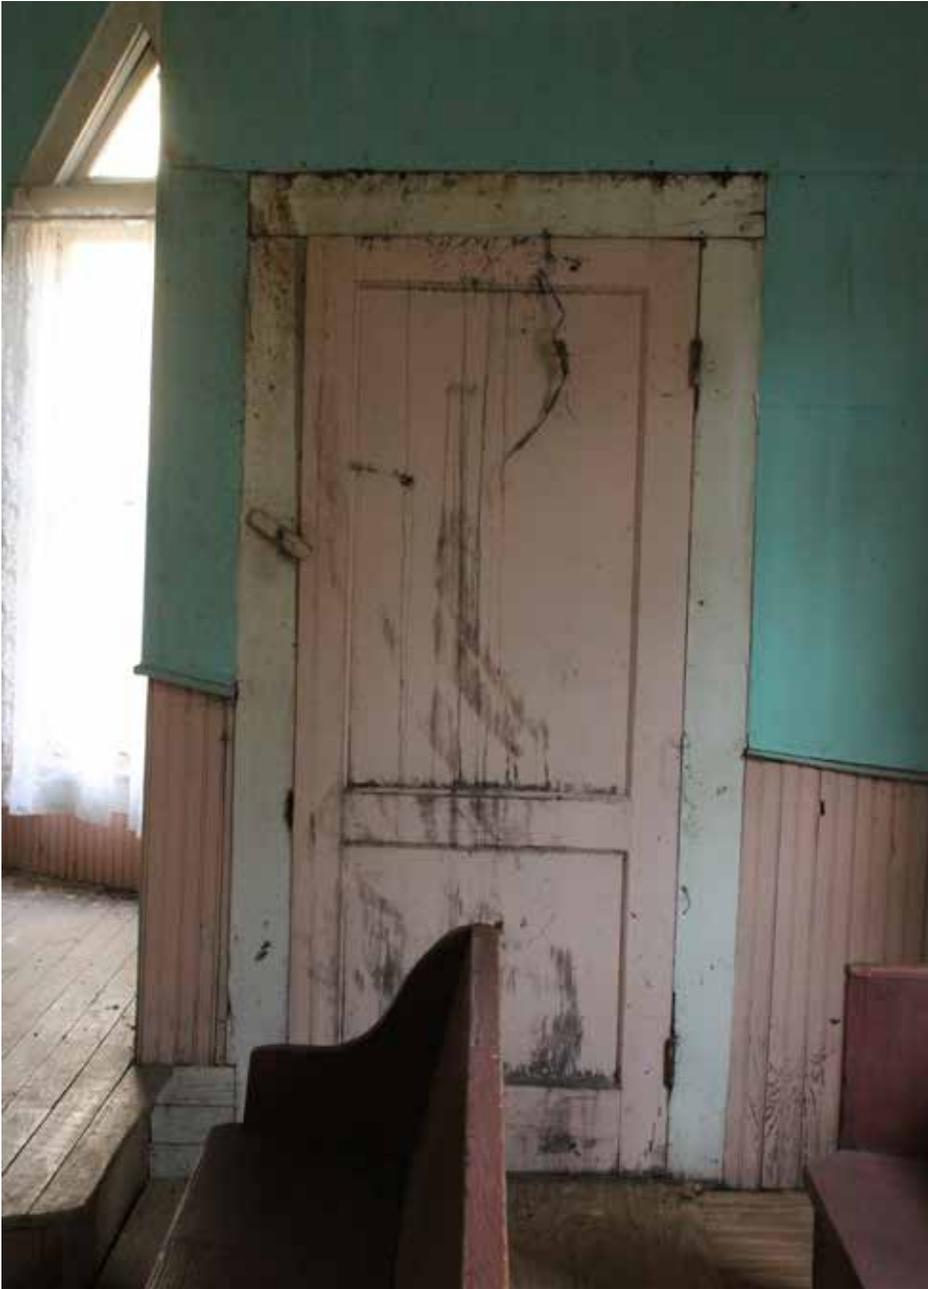
Figure 59. Plywood has been placed at the base of the door, likely to cover deteriorated wood.

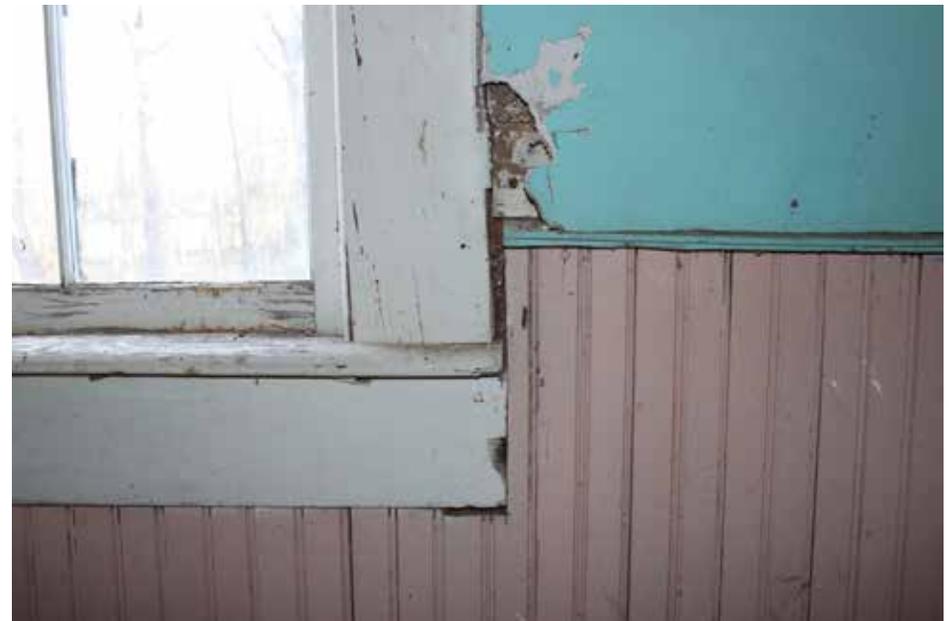
Figure 61.

- Inappropriate drywall is cracking and portions are pulling away from the beadboard underneath.
- South corner covered in plywood.

- Remove all drywall. This removal should be performed carefully so as not to damage the beadboard underneath. Condition of the concealed beadboard remains unknown, but repairs can be reasonably expected. Based on an assessment of the materials, selective replacement of beadboard should be carried out if necessary. New beadboard should match the adjacent material in species, dimension, and profile. Loose beadboard should be attached to framing.
- Remove plywood to assess the condition of framing and beadboard underneath. This corner is directly

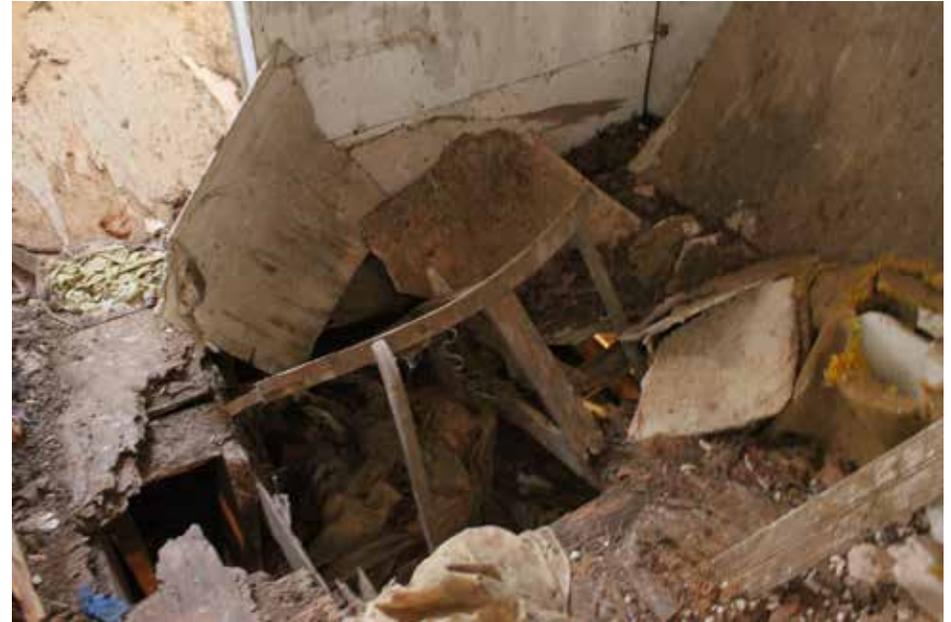
Figure 77. Caved in floor

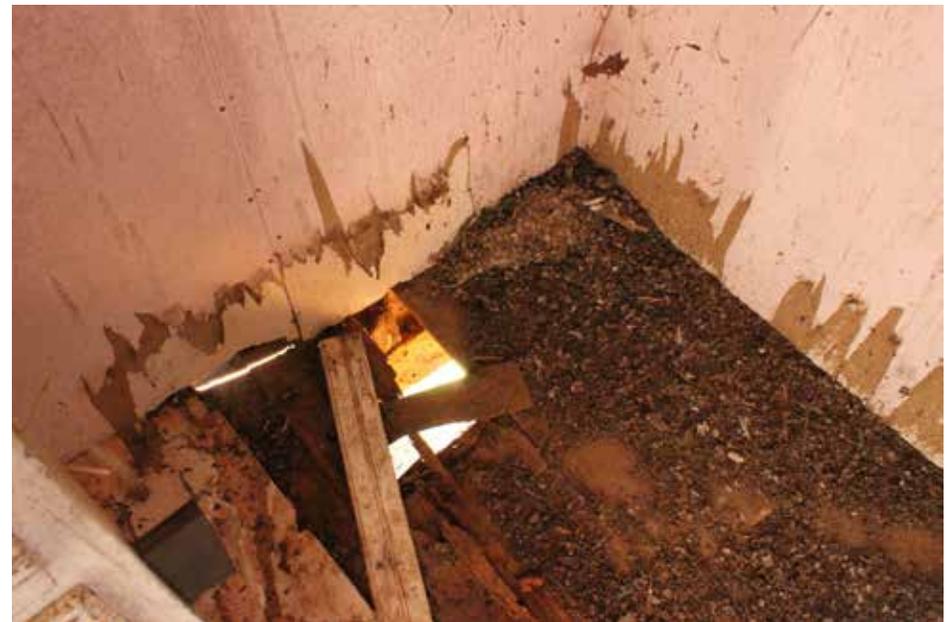
Figure 78. Caved in floor

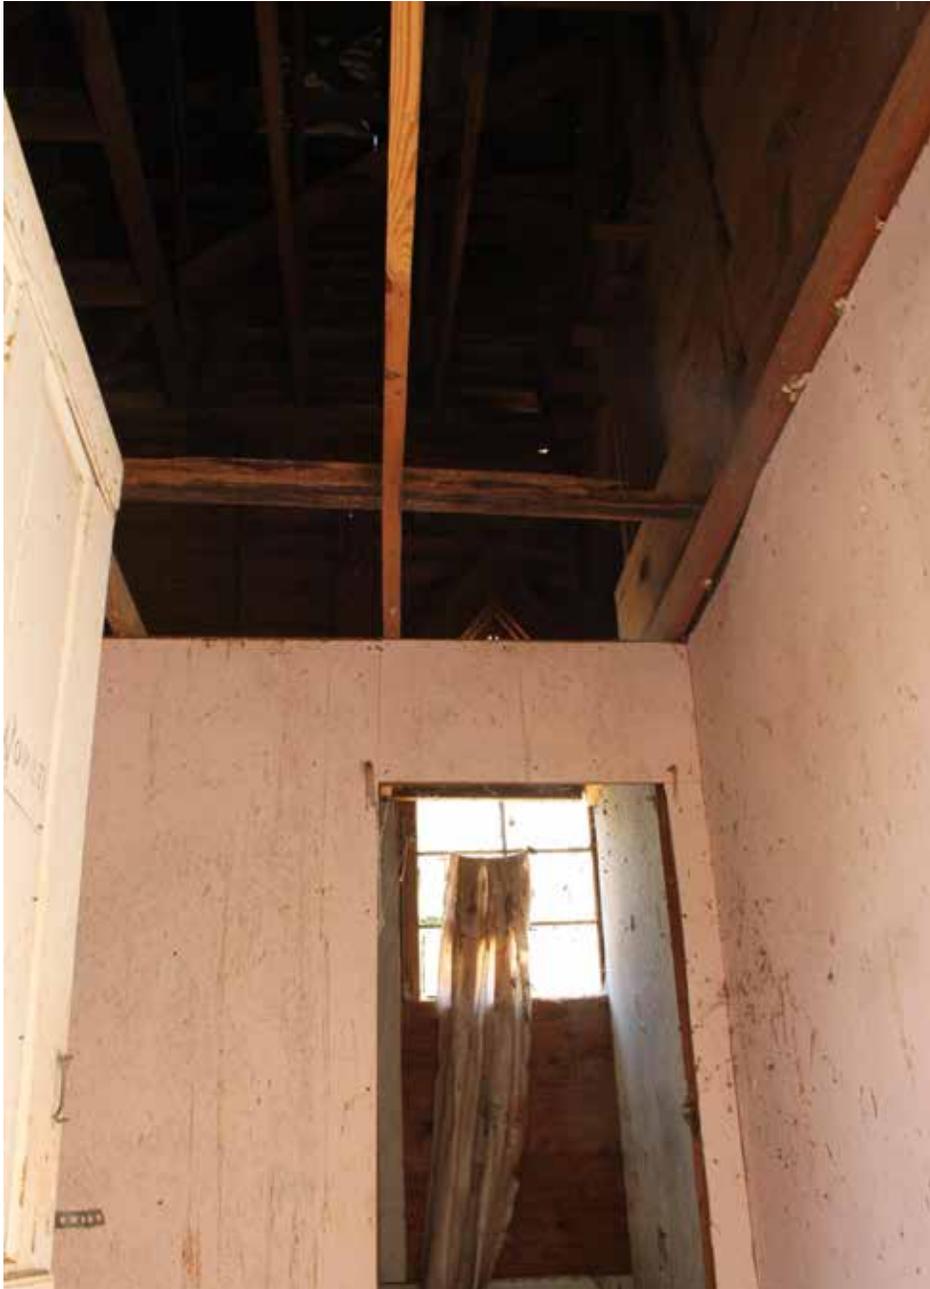
Figure 79. The ceilings have collapsed in the restrooms
