CONDITIONS ASSESSMENT

ANTIOCH BAPTIST CHURCH

CRAWFORDVILLE, GA

LANDMARK PRESERVATION LLC
SPRING 2020

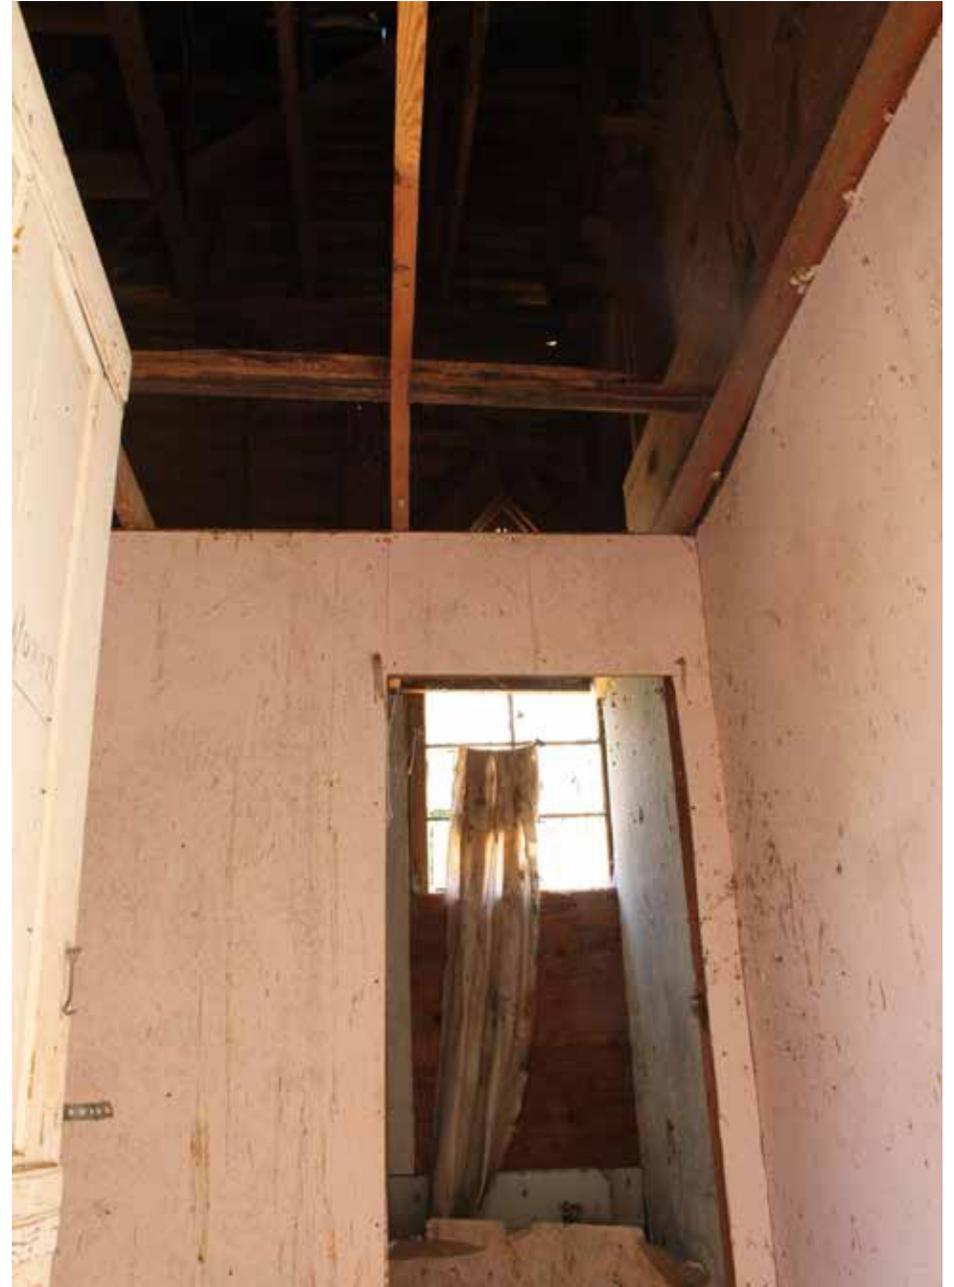
Figure 11.

Separate men's and women's restrooms are located in the front of the building, one inside each tower. The entire ceiling in both spaces has collapsed to expose the roof framing above. Large portions of the floor in the women's bathroom are missing while almost the entire floor in the men's restroom has collapsed. Both spaces are finished in drywall.

It should be noted that the restrooms are in poor condition and are not currently functional.

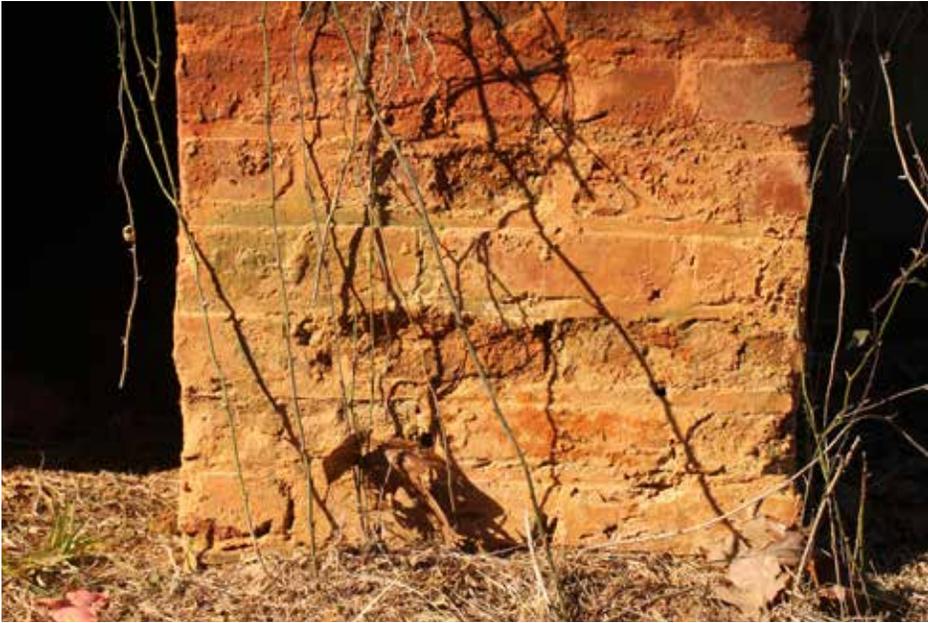
Figure 16.

- Organic growth
- Deteriorated mortar
- Spalling brick
- Missing bricks (northwest corner)
- One brick pier replaced with concrete
- Sinking piers
- Grade buildup

- Biological growth should be gently removed by hand, and piers should be treated with a biological cleaner and growth inhibitor (D/2 Biological Solution or equivalent).
- Existing deteriorated mortar (lime based) should be gently removed and bricks should be repointed. New mortar should match historic mortar in color, texture, joint profile, and composite strength.
- Spalled bricks should be carefully removed in a manner that does not cause damage to adjacent bricks.

- Replacement bricks should be laid by a qualified mason. Any new bricks to match existing in dimension, color, and texture as accurately as possible.
- Rebuild three piers (two brick, one stone - northwest corner) to level.
- Jack building to alleviate deflection and repair framing in kind (see spalling section).
- Excavate grade to original level on southeast elevation.

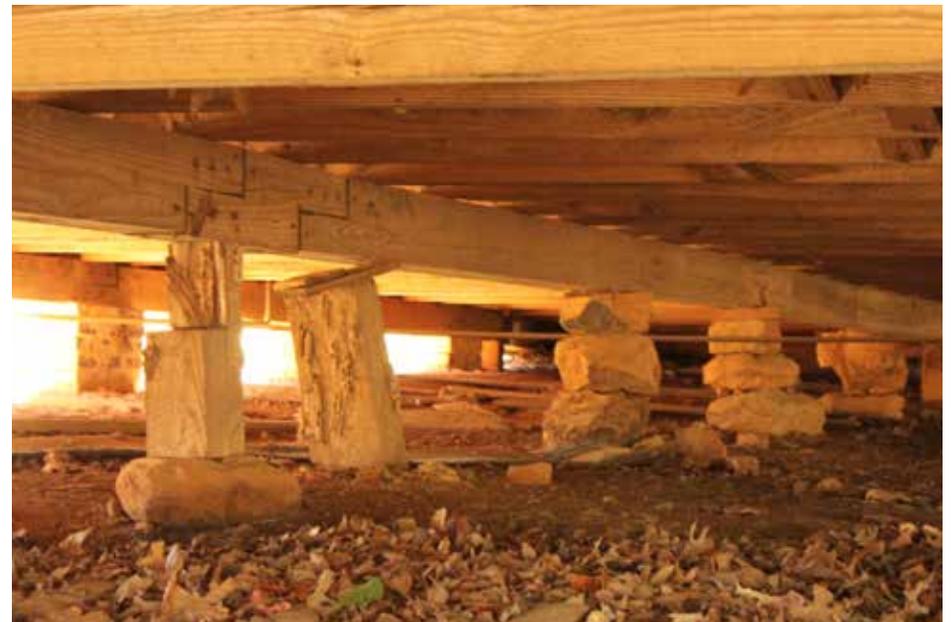
Figure 20.

- One of the piers is a combination of wood and stone.
- One additional pier has been replaced with a wood block.

- Confirm stability of existing piers
- Replace wooden pier elements with appropriate stone

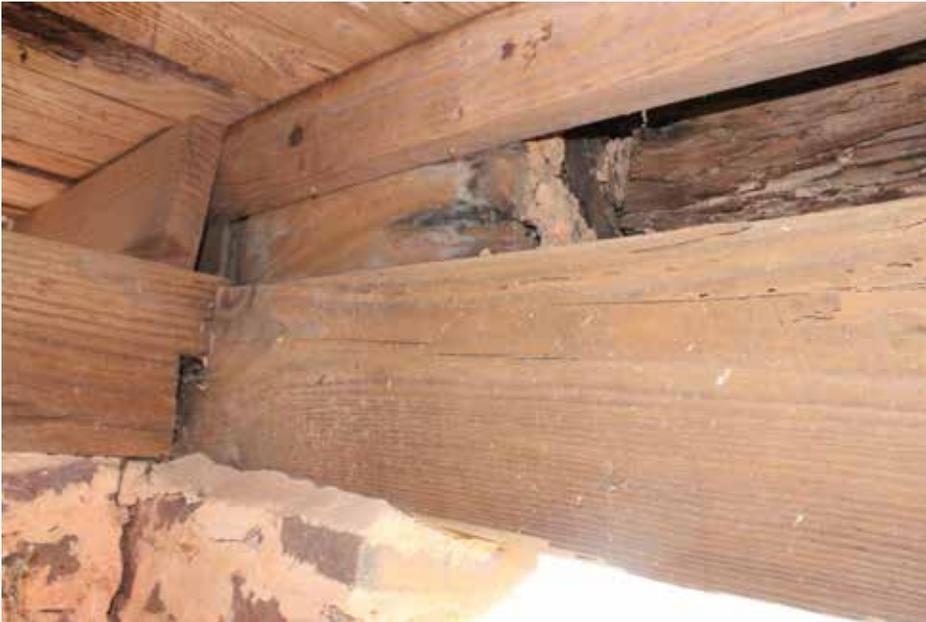
Figure 25.

- Termite mound
- Termite damage

- Treat the ground and building for termites and other wood destroying organisms.
- Closely inspect for termite damage in framing.

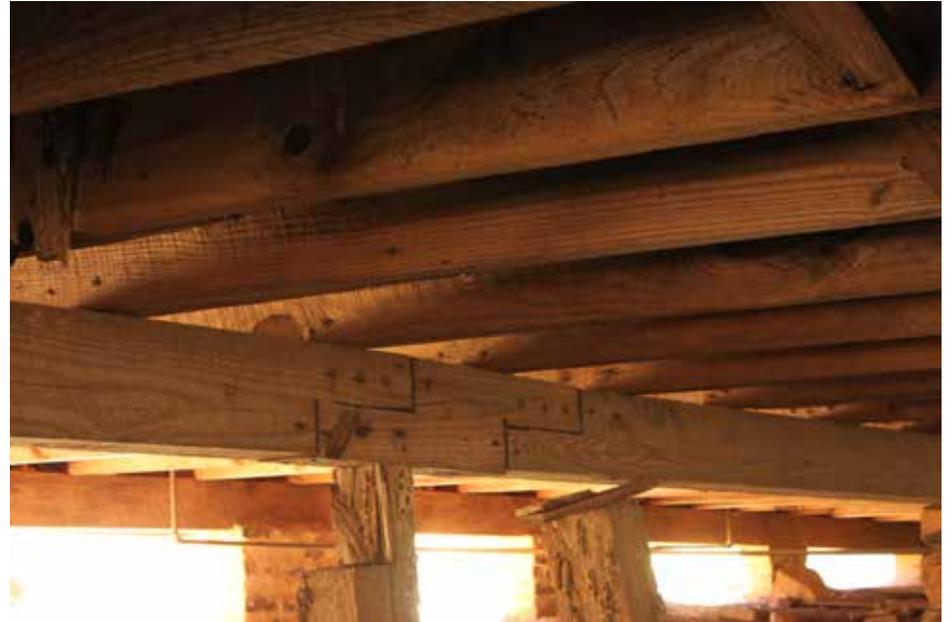
Figure 27.

- Deteriorated timbers visible from crawl space.
- Sagging porch deck
- Structurally inappropriate joinery in summer beam.
- Water entry has deteriorated some of the rafters and tower framing elements over the restrooms.

- The bottom of all wall framing is currently concealed by the siding, and a full inspection is not possible. Remove bottom two courses of siding from the building in order to fully expose piers, sills, and bottom of wall framing. Upon removal of siding, the precise condition of the studs can be determined.

Jacking will occur in order to relieve stress caused by deterioration and deflection of structural members, and to permit the repair of sills and framing as described in the section below. It should be noted that depending on the amount of floor deflection, it may not be advisable to completely level all floors. A final determination will be made on-site.

Provide and install temporary shoring to reinforce existing pier foundation system. Temporary shoring to consist of solid concrete blocks, dry-laid, where required.

Studs with minor to moderate deterioration will be sistered where possible utilizing material of in-kind dimension and species. Severely deteriorated members will be replaced utilizing material of in-kind dimension and species where absolutely required.

Repair sills to eliminate minor deterioration where required. Loose material will be removed in order to establish stable material. Deteriorated areas will be treated with a wood consolidant. Minor voids will then be filled with a wood repair epoxy. Larger areas of deterioration will be repaired with an in-kind Dutchman. Severely deteriorated sill members will be replaced where necessary. Replacement sill members will match existing in species and dimension. Minor deterioration will be consolidated where required.

- Sister inappropriate joinery in summer beam with steel plates and through-bolts.
- Determine the causes of water

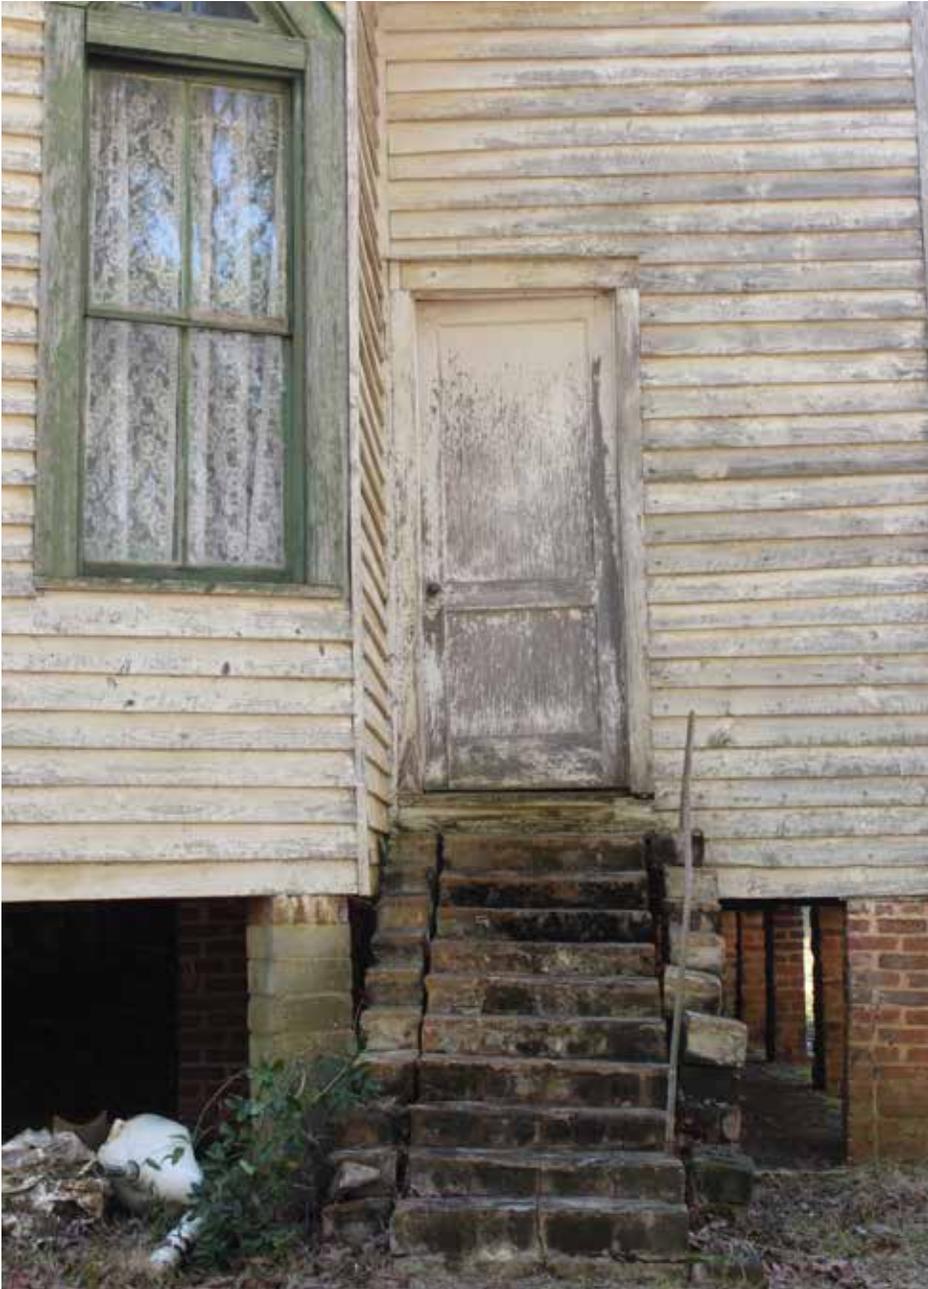
Figure 31.

- Cracks in blocks
- Edge blocks pulling away
- Biological growth

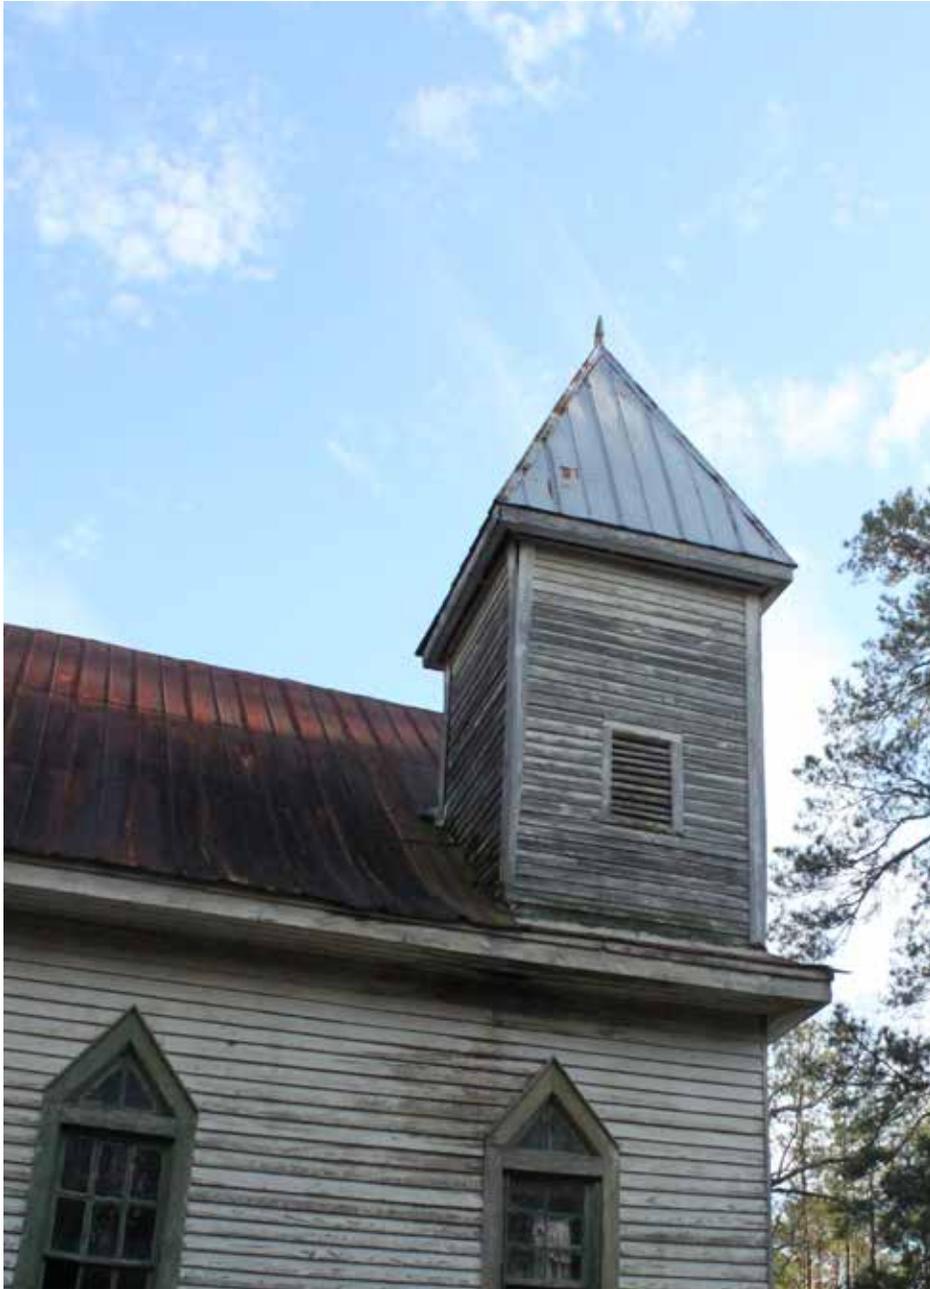
Figure 52.

- Leaning masonry chimney suspended over sanctuary ceiling is at risk of complete failure and presents an immediate threat to life safety.
- Damaged bird wire on attic louvers has allowed birds access to the attic and resulted in a blanketing of droppings.

- **Remove masonry chimney as a life safety precaution. The heavy mass is leaning perilously and potential for imminent collapse presents a very real threat to the safety of anyone entering the structure.**
- Replace bird wire on attic vent louvers.

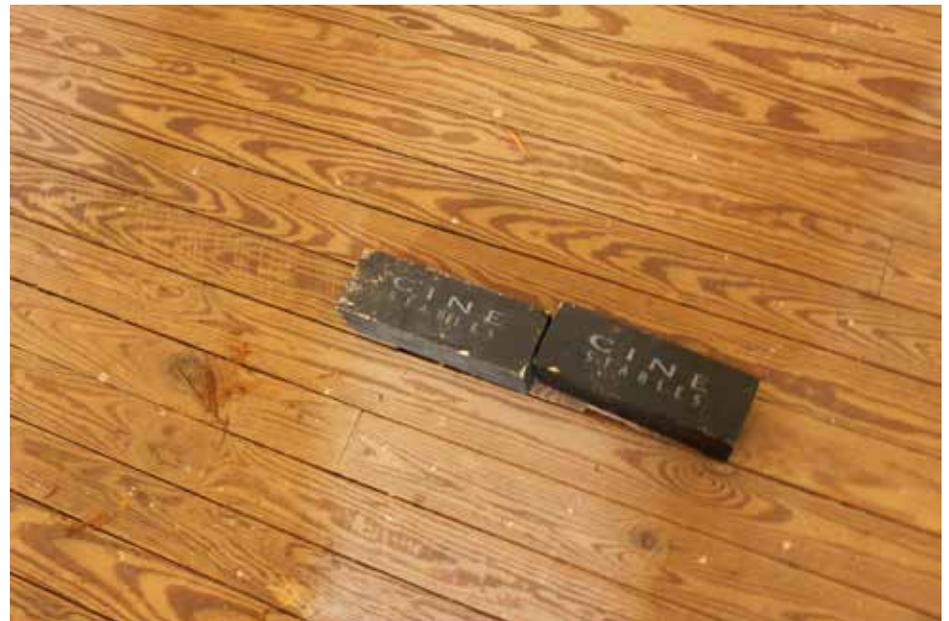
Figure 58. The blocks are covering a substantial hole in the floor

- Remove all deteriorated flooring and replace with flooring to match existing in species, dimension, and joints.
- Holes to be filled and gouges to be repaired by qualified carpenter once the chimney and its requisite supporting column have been removed.

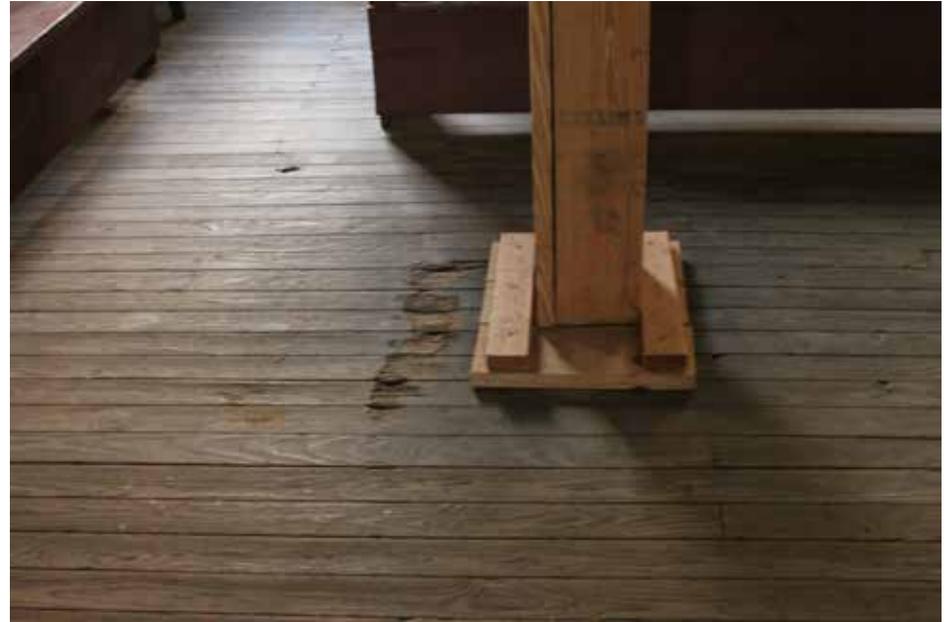
Figure 60.

- Deteriorated flooring covered by plywood in the southern and eastern corners.
- Scattered holes
- Gouges under column supporting chimney.

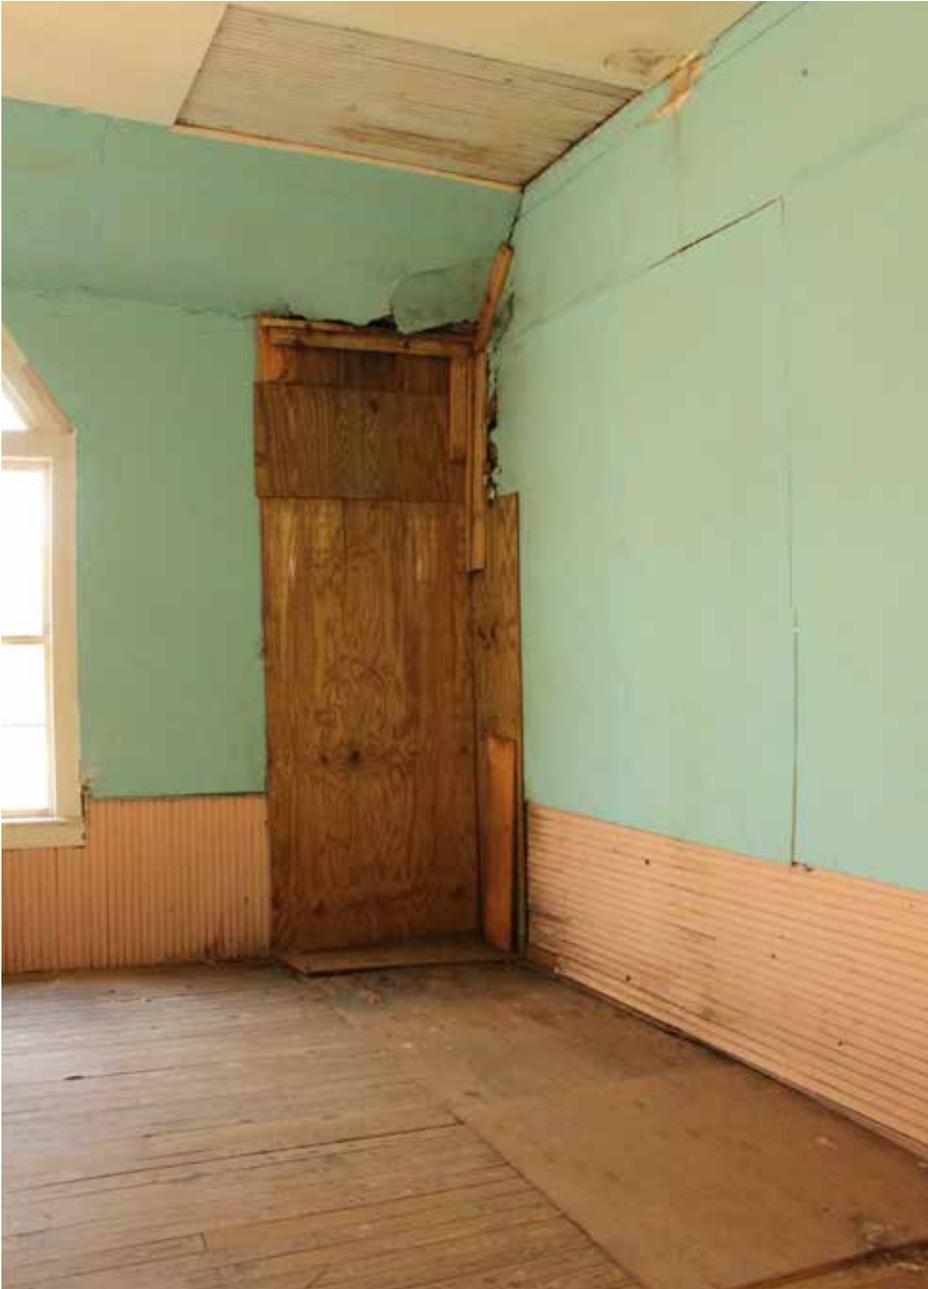
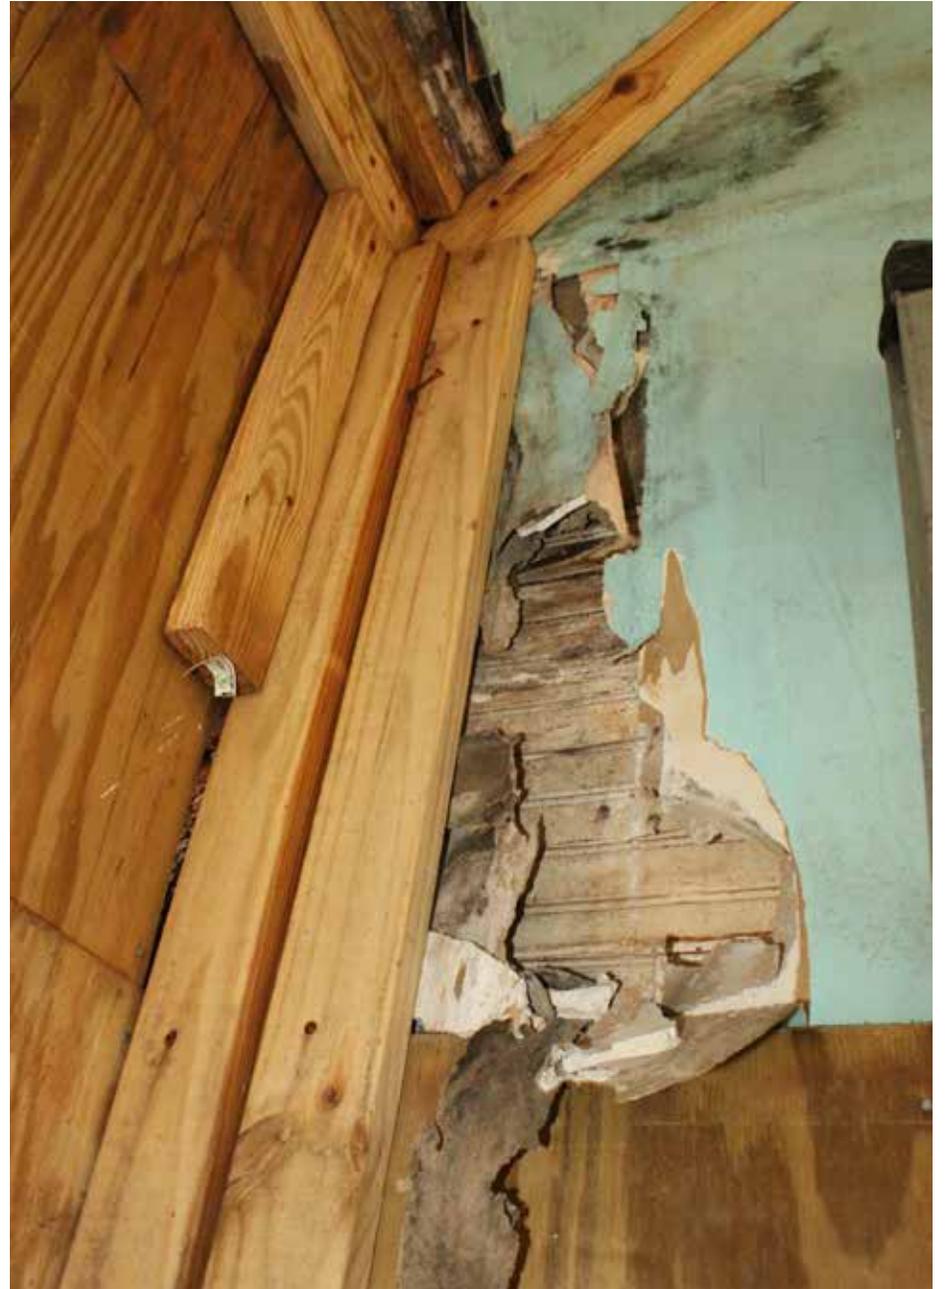
- Inappropriate drywall is cracking and portions are pulling away from the beadboard underneath.
- South corner covered in plywood.

- Remove all drywall. This removal should be performed carefully so as not to damage the beadboard underneath. Condition of the concealed beadboard remains unknown, but repairs can be reasonably expected. Based on an assessment of the materials, selective replacement of beadboard should be carried out if necessary. New beadboard should match the adjacent material in species, dimension, and profile. Loose beadboard should be attached to framing.
- Remove plywood to assess the condition of framing and beadboard underneath. This corner is directly

under some of the significant framing deterioration seen in the attic. Any assessment by a structural engineer, if deemed necessary, should also include an assessment of the framing presently concealed by the plywood. Once the plywood has been removed, and a structural assessment has been made, it is assumed that repairs will be necessary to the framing. These repairs should be undertaken by a qualified carpenter. The beadboard should be replaced in this corner to match the adjacent beadboard in species, dimension, and profile.

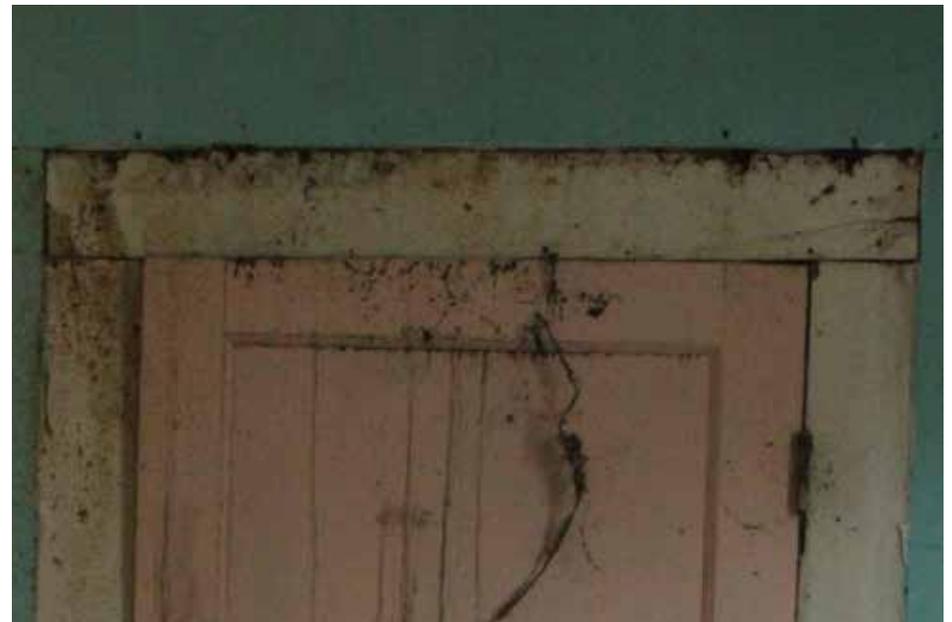
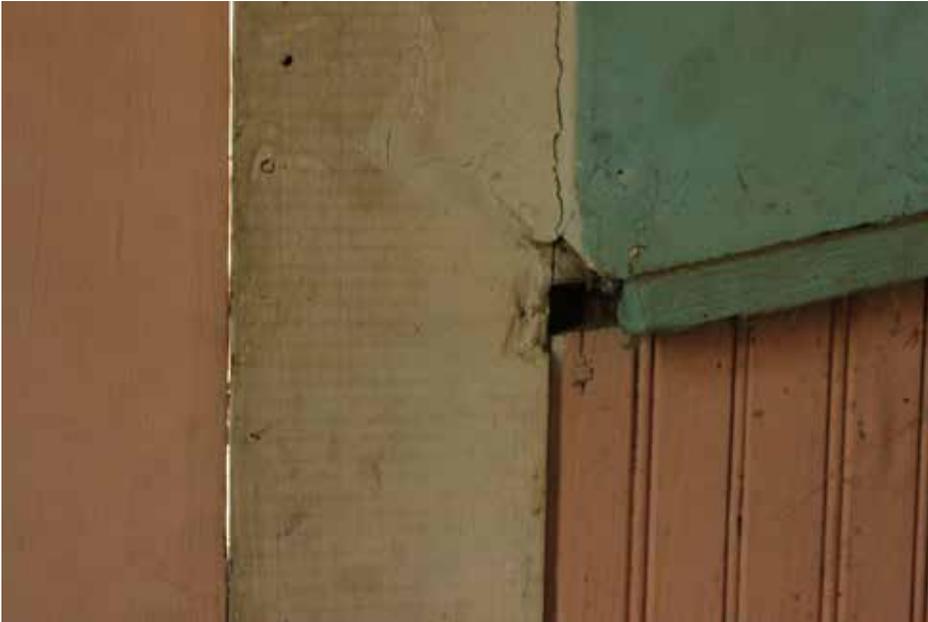
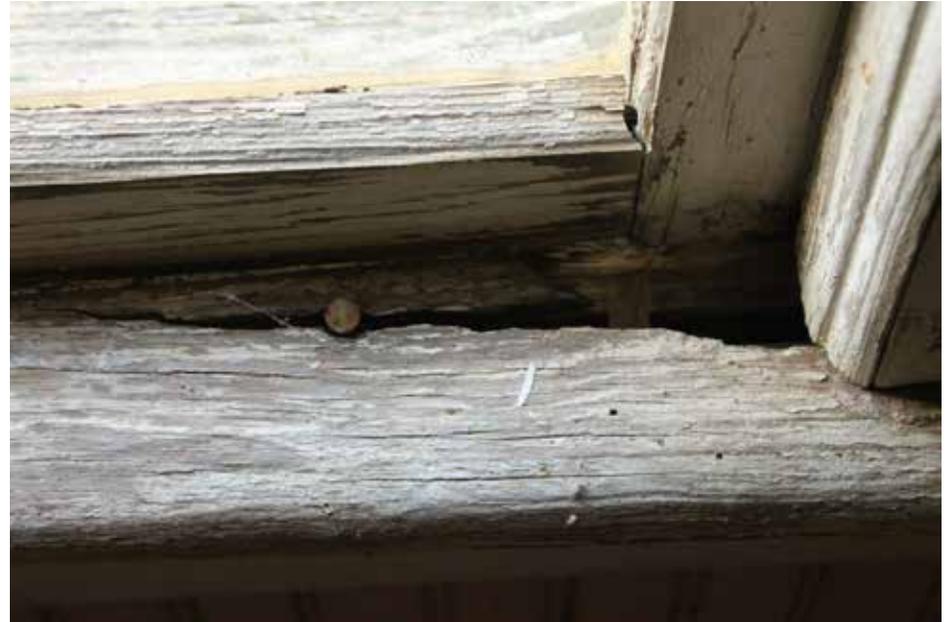
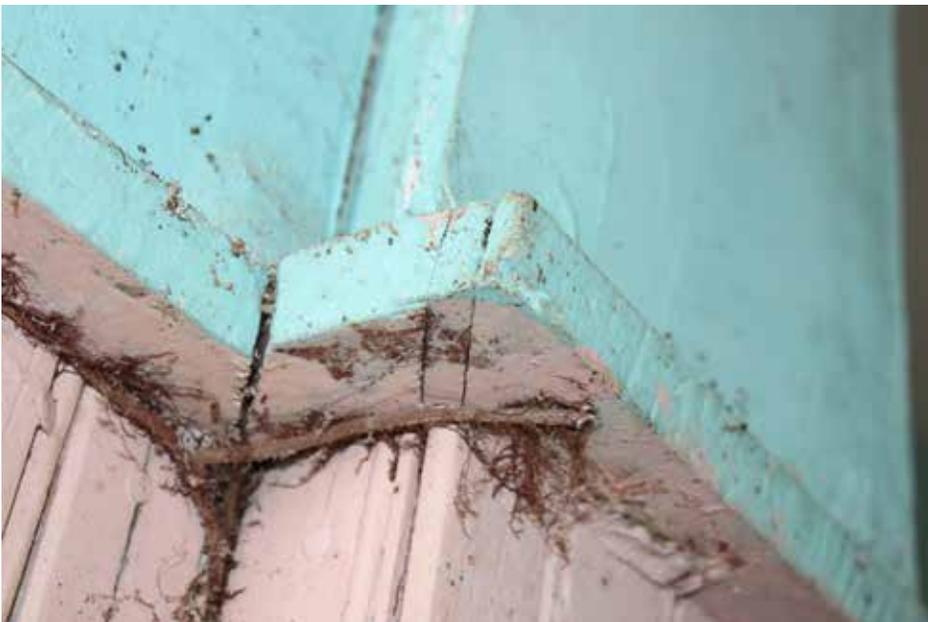
- Deteriorating window sills
- Loose / Missing chair rail
- Loose window trim
- Biological growth
- Failed paint

- Repair window sills to eliminate minor deterioration where required. Loose material will be removed in order to establish stable material. Deteriorated areas will be treated with a wood consolidant. Minor voids will then be filled with a wood repair epoxy. Larger areas of deterioration will be repaired with an in-kind Dutchman. Severely deteriorated window sill members will be replaced where necessary. Replacement sill members will match existing in species and dimension. Minor deterioration will be consolidated where required.
- Re-attach all loose chair rail and window trim in good repair with appropriate fasteners.
- Limited replacement of rotten, damaged, or missing chair rail and trim with elements that match in size, species, and dimension.
- Biological growth should be gently removed by hand.

A comprehensive finish analysis should be conducted to determine historic finishes prior to any interior painting. Once analysis samples have been taken, scrape loose and failing paint using hand tools. Great care should be taken to avoid gouging the wood. Sand to remove rough surfaces and previous careless tool marks. Appropriate primer and paint should then be applied with brushes.

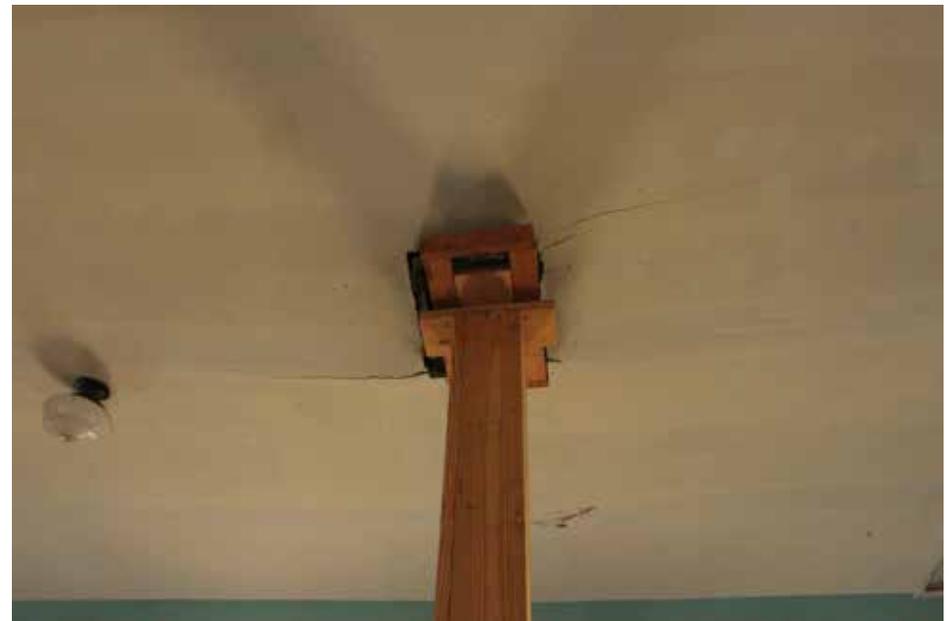
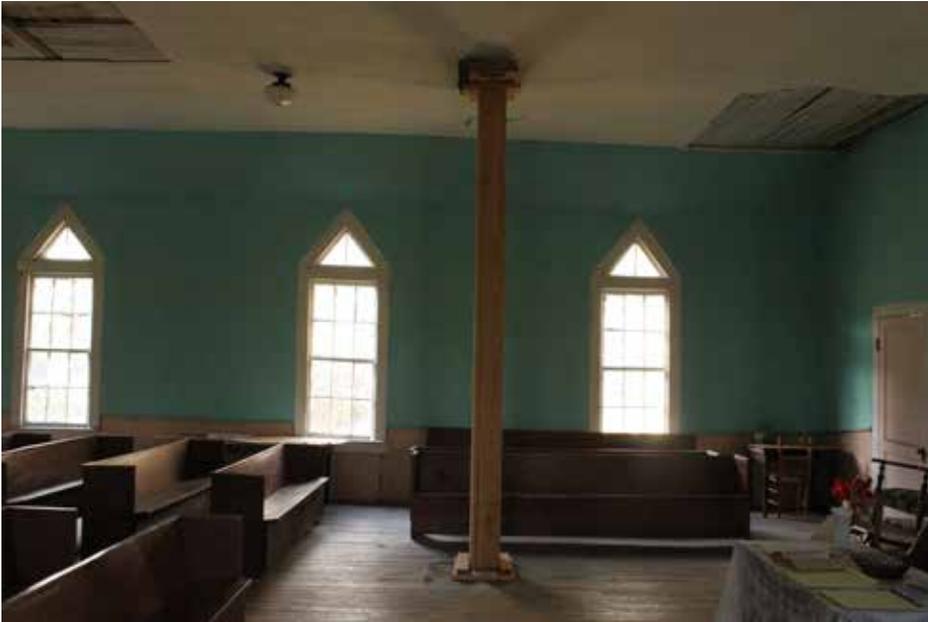
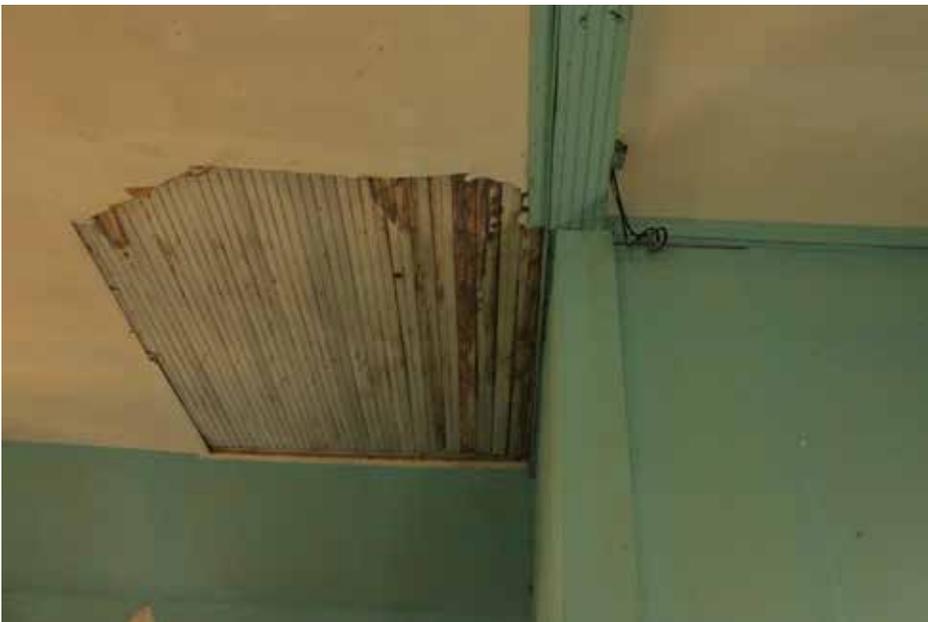
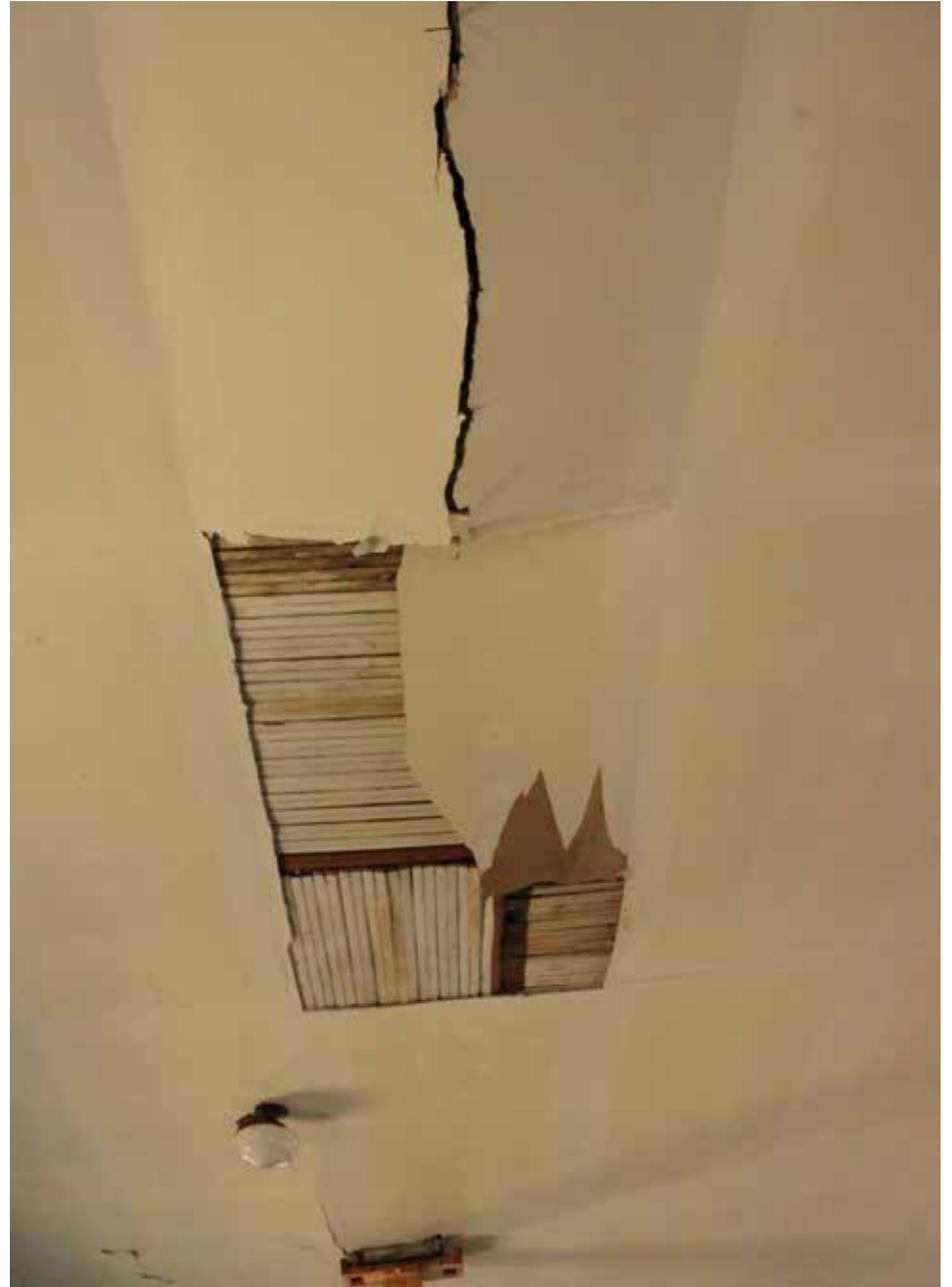
- Mold
- Cracks in drywall
- Sections of drywall completely missing
- Chimney support pushing into drywall ceiling

- Remove all inappropriate drywall. This removal should be performed carefully so as not to damage the beadboard underneath. Condition of the concealed beadboard remains unknown, but repairs can be reasonably expected. Loose beadboard should be re-attached to ceiling joists. Based on an assessment of the materials, selective replacement of beadboard should be carried out if necessary. New beadboard should match the adjacent material in species, dimension, and profile.
- **Removal of chimney mass in attic will**

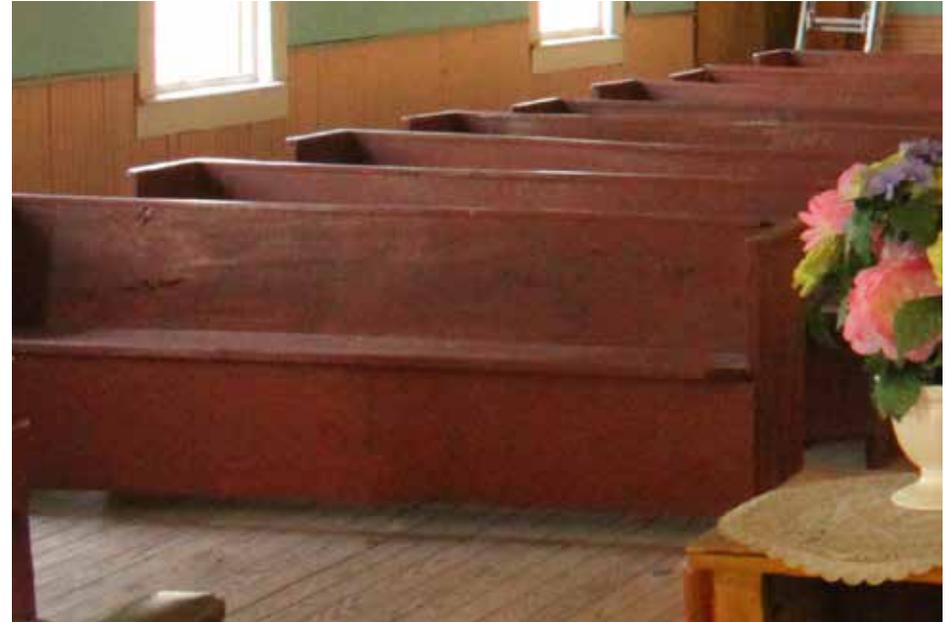
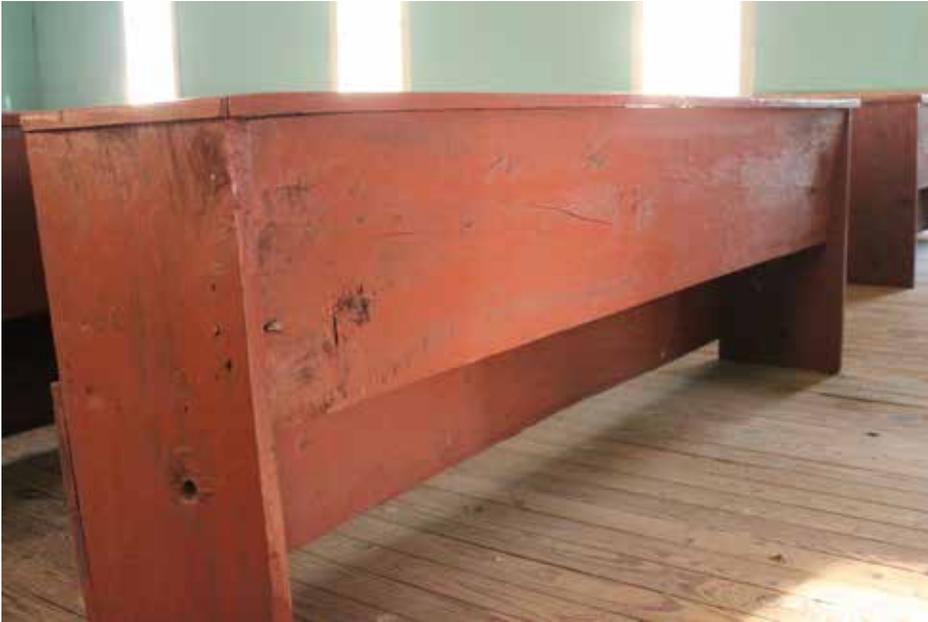
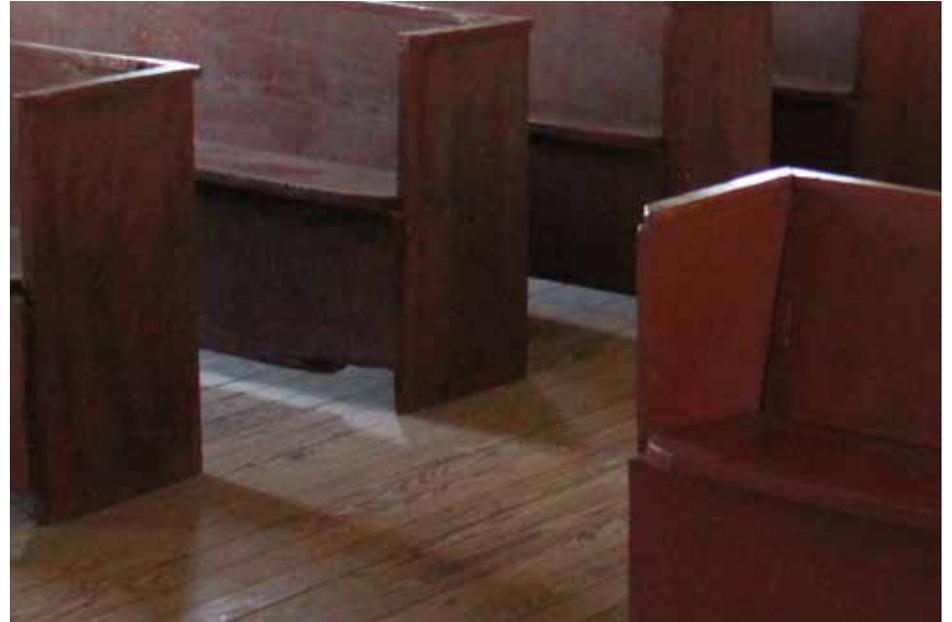
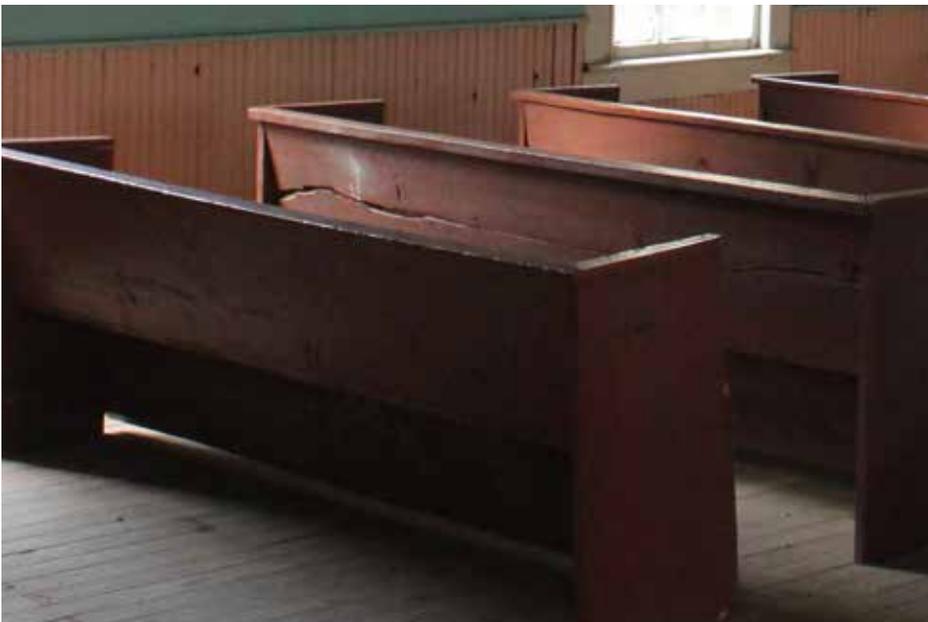
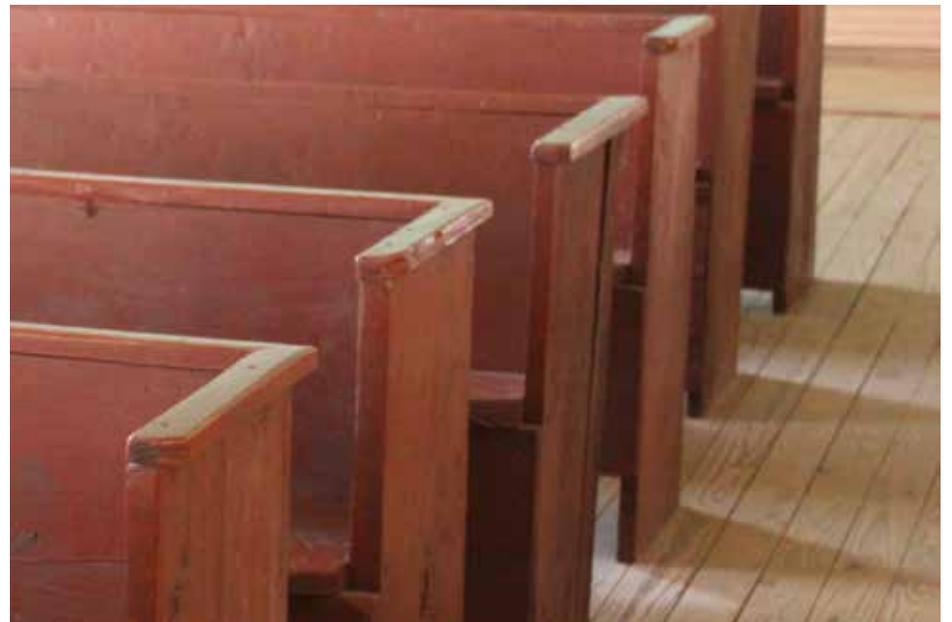
- Varying degrees of cracks
- Missing sections of wood
- Gouges in wood

- Retain all pews found within the building. Should removal of the pews be required to perform any of the work recommended in this assessment, great care should be taken to remove said pews. They are to remain in a secure area on site.

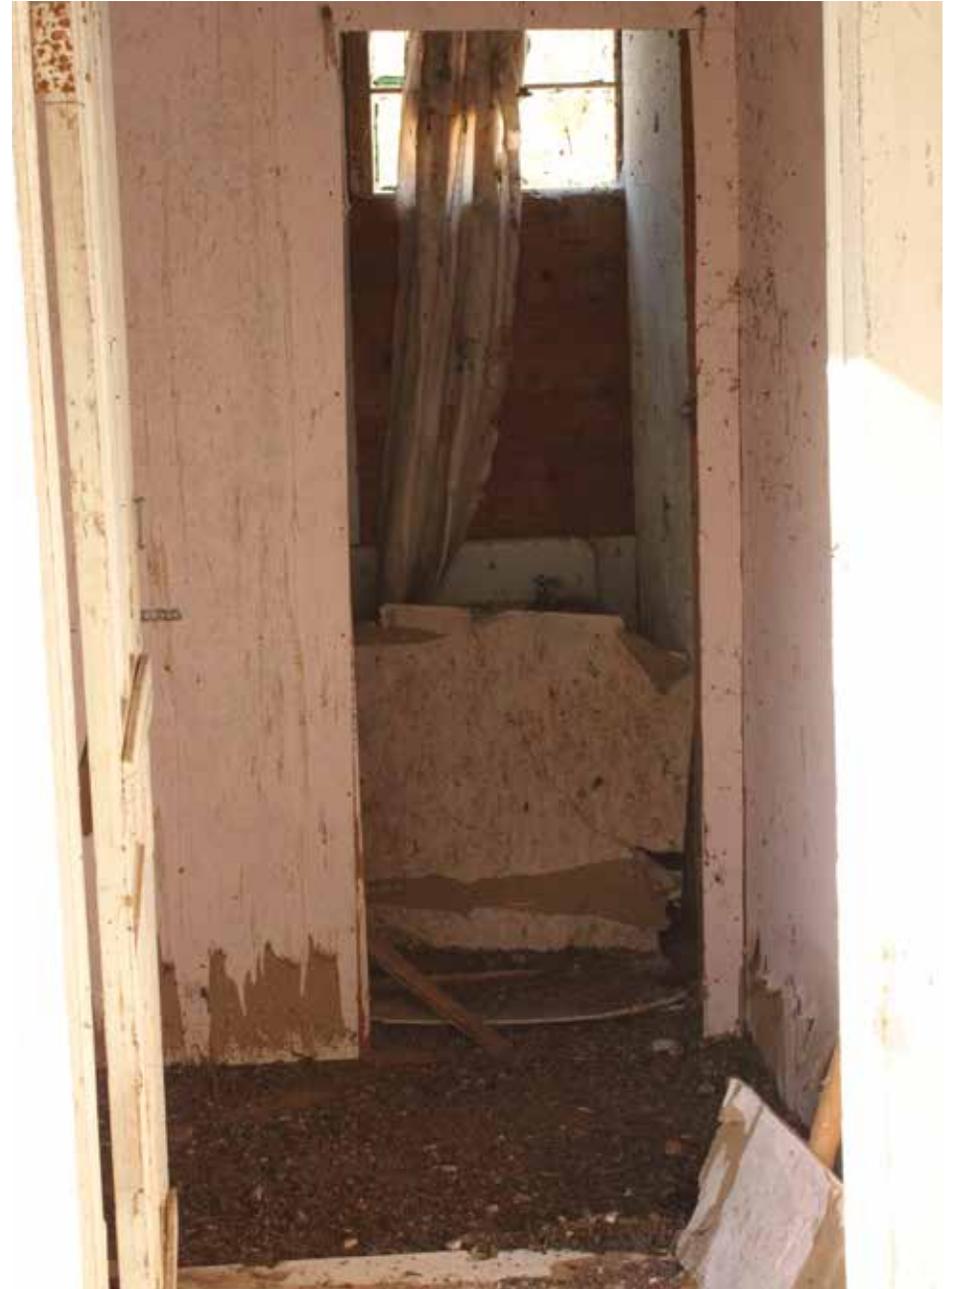
Figure 80.

- Large portions of the floor have rotted away and collapsed.
- Ceilings have completely collapsed.
- Framing and drywall finishes show extensive water damage.

- Remove and replace all deteriorated wood flooring and subflooring. New flooring should match existing in species, dimension, and profile.
- Due to the extensive damage present in both bathrooms, the removal of all drywall is recommended.

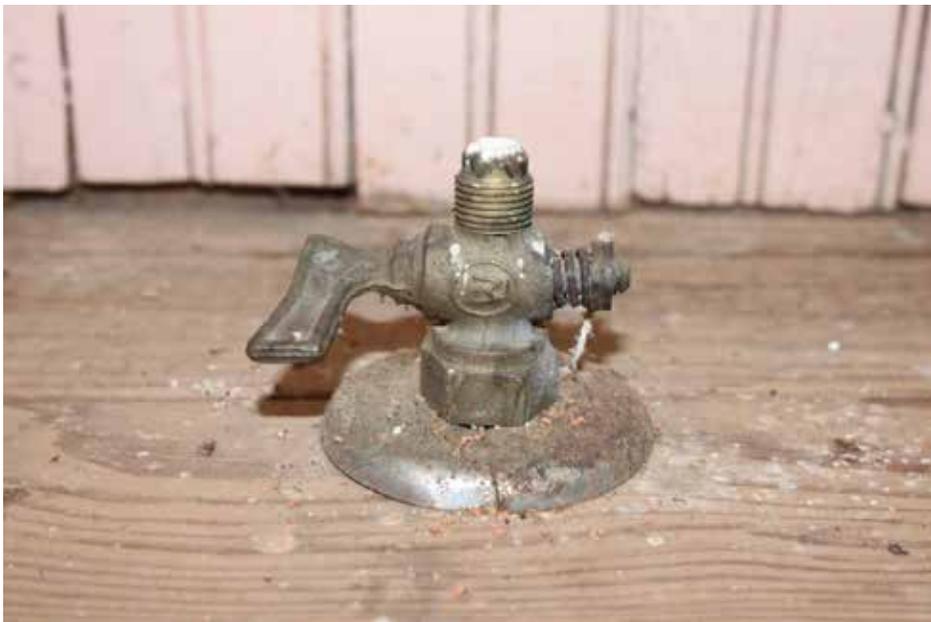
Figure 84. Part of a gas line and hookup.

- Confirm status of utilities.
- Retain all fixtures found within the building or site. Should removal of fixtures be required to perform any of the work recommended in this assessment, great care should be taken to remove said fixtures. All fixtures are to remain in a secure area on site.

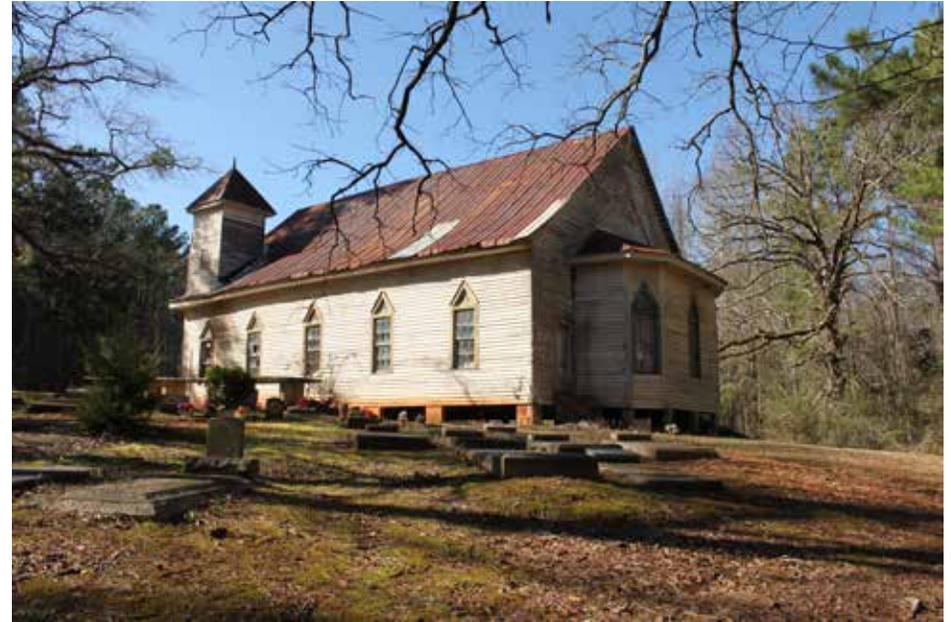
Figure 85.

- Unmarked graves
- Overgrown markers
- Damaged or broken grave markers
- Build up of dirt and grime

- Ensure that all graves are clearly marked, to include unmarked graves, and are visible
- Defoliate, by hand, any overgrown grave makers to ensure visibility.
- Identify unmarked graves using ground penetrating radar (GPR), cadaver dogs, or similar methods
